Asbestos Management Survey

Christ The King R C Primary School

A & L Reference : 28329
Building Reference : 344/2214

Allport Road
Bromborough
Wirral
CH62 6AE

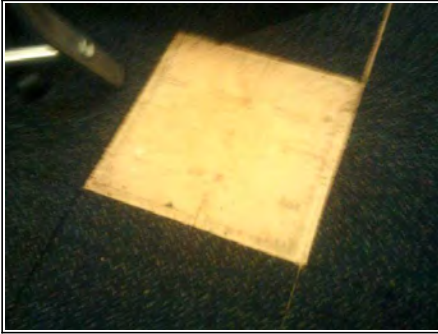
Room Number: 0-002		Room Reference: Main School Office		Review Date: 18-02-2020
	Asbestos Detected	Sample Reference	Asbestos Type	Product Type	Surface Treatment
	Asbestos Confirmed	001	Chrysotile	Floor Tiles	Floor Tiles.
		Extent	Condition	Accessibility	Risk Score
		10-15m ²	0 - Good	Difficult	2

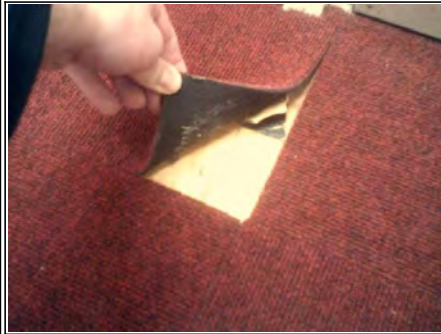
Asbestos Confirmed	Room Number: 0-005		Room Reference: Headteachers Office		Review Date: 18-02-2020
	Asbestos Detected	Sample Reference	Asbestos Type	Product Type	Surface Treatment
		As001	Chrysotile	Floor Tiles	Floor Tiles.
	Extent	Condition	Accessibility	Risk Score	
	5-10m ²	0 - Good	Difficult	2	
	Comment:	The beige floor tiles (including the bitumen adhesive) beneath carpet were seen to be in good condition at the time of the survey.			
Recommendation:	The condition of the floor tiles should be monitored.

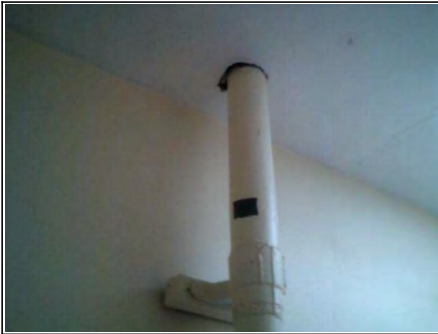
Room Number: 0-008		Room Reference: Female Staff Toilet		Review Date: 18-02-2020
	Asbestos Detected	Sample Reference	Asbestos Type	Product Type	Surface Treatment
	Asbestos Confirmed	002	Chrysotile	Cement Flue Pipe	Sealed Cement
		Extent	Condition	Accessibility	Risk Score
		1-5LM	0 - Good	Difficult	3

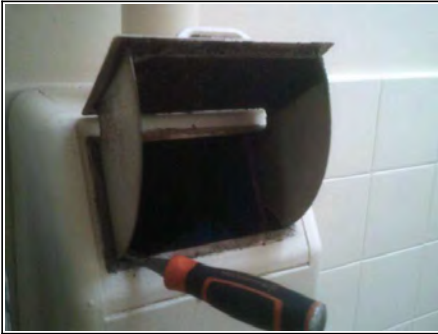
Room Number: 0-008		Room Reference: Female Staff Toilet		Review Date: 18-02-2020
	Asbestos Detected	Sample Reference	Asbestos Type	Product Type	Surface Treatment
	Asbestos Confirmed	003	Chrysotile	Cement Panel(s)	Cement
		Extent	Condition	Accessibility	Risk Score
		Number x 01	0 - Good	Difficult	3

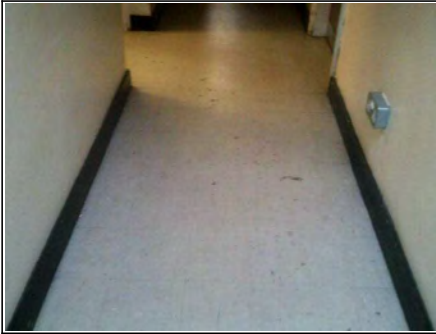
Room Number: 0-010		Room Reference: Corridor		Review Date: 18-02-2020
	Asbestos Detected	Sample Reference	Asbestos Type	Product Type	Surface Treatment
	Asbestos Confirmed	004	Chrysotile	Floor Tiles	Floor Tiles.
		Extent	Condition	Accessibility	Risk Score
		5-10m ²	0 - Good	Easy	2

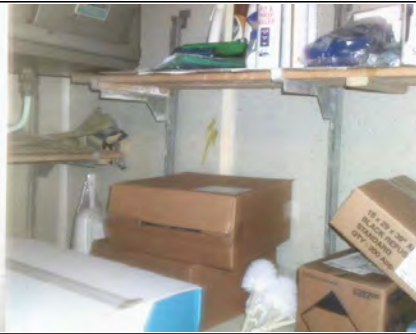
Room Number: 0-018		Room Reference: Store		Review Date: 18-02-2020
	Asbestos Detected	Sample Reference	Asbestos Type	Product Type	Surface Treatment
	Asbestos Confirmed	005	Chrysotile	Cement Panel(s)	Sealed Cement
		Extent	Condition	Accessibility	Risk Score
	15-20m ²	0 - Good	Easy	3

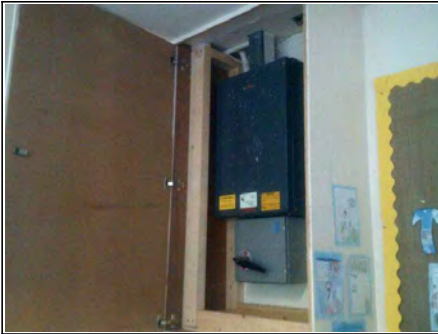
Room Reference Product Type	Risk Score	Comment	Recommendation
0-022 Classroom Suspect Electrics	3	No Access was possible into the internal sections of the live suspect electrical systems at the time of the survey.	If the electrical systems are to be decommissioned and removed from site, then the whole units should be inspected further when disconnected or be removed intact and be disposed of as asbestos waste.
Internal To School No Access	3	No Access was possible into the live suspect heaters throughout the school at the time of the survey.	The presence of asbestos containing materials should be presumed until further investigation is carried out. Further investigation is recommended prior to demolition or major refurbishment works.
Internal To School No Access	3	No Access was possible into the Subterranean Floor Ducts throughout the school at the time of the survey.	The presence of asbestos containing materials should be presumed until further investigation is carried out. Further investigation is recommended prior to demolition or major refurbishment works.

Room Number: 0-022		Room Reference: Classroom		Review Date: 18-02-2020
	Asbestos Detected	Sample Reference	Asbestos Type	Product Type	Surface Treatment
	No Access	Suspect Electrics		Suspect Electrics	
		Extent	Condition	Accessibility	Risk Score
					3

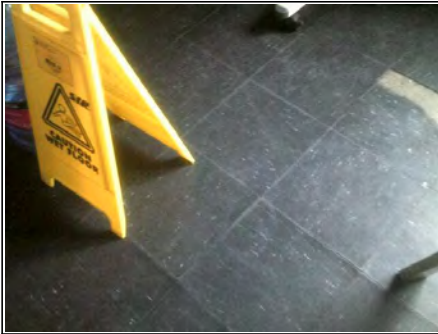
Room Number: 0-037		Room Reference: Lobby		Review Date: 18-02-2020
	Asbestos Detected	Sample Reference	Asbestos Type	Product Type	Surface Treatment
	Asbestos Confirmed	010	Chrysotile	Bitumen Adhesive	Floor Tiles.
		Extent	Condition	Accessibility	Risk Score
	10-15m ²	1 - Low Damage	Difficult	3

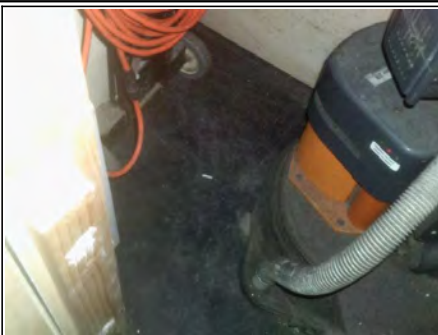
Room Number: 0-038		Room Reference: Under Stair Store		Review Date: 18-02-2020
	Asbestos Detected	Sample Reference	Asbestos Type	Product Type	Surface Treatment
	Asbestos Confirmed	As010	Chrysotile	Bitumen Adhesive	Floor Tiles.
		Extent	Condition	Accessibility	Risk Score
	1-5m ²	1 - Low Damage	Difficult	3

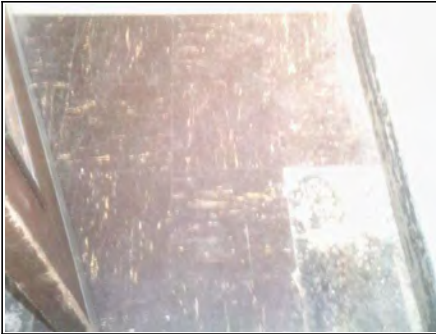
0-042 Caretakers Office Floor Tiles	4	The brown floor tiles (including the bitumen adhesive) were seen to have areas of medium/high damage at the time of the survey.	The floor tiles (including the bitumen adhesive) should be repaired or removed under controlled conditions and disposed of as asbestos waste.
0-044 Classroom Floor Tiles	2	The cream floor tiles beneath the carpet were seen to be in good condition at the time of the survey.	The condition of the floor tiles should be monitored.
0-047 Classroom Floor Tiles	2	The cream floor tiles beneath the carpet were seen to be in good condition at the time of the survey.	The condition of the floor tiles should be monitored.
0-048 Classroom Floor Tiles	2	The cream floor tiles beneath the carpet were seen to be in good condition at the time of the survey.	The condition of the floor tiles should be monitored.

Room Number: 0-042		Room Reference: Caretakers Office		Review Date: 18-02-2020
	Asbestos Detected	Sample Reference	Asbestos Type	Product Type	Surface Treatment
	Asbestos Confirmed	012	Chrysotile	Floor Tiles	Floor Tiles.
		Extent	Condition	Accessibility	Risk Score
	1-5m ²	2 - Med Damage	Easy	4

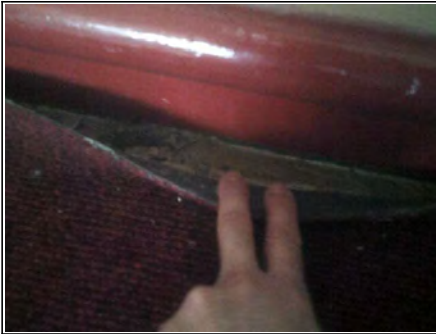
Room Number: 0-044		Room Reference: Classroom		Review Date: 18-02-2020
	Asbestos Detected	Sample Reference	Asbestos Type	Product Type	Surface Treatment
	Asbestos Confirmed	013	Chrysotile	Floor Tiles	Floor Tiles.
		Extent	Condition	Accessibility	Risk Score
	50-75m ²	0 - Good	Difficult	2

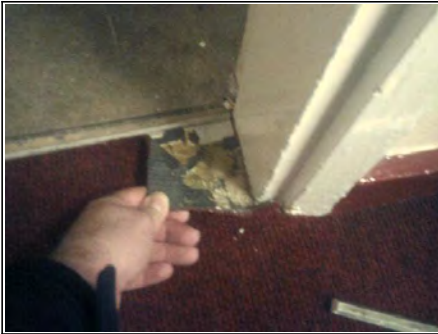
Room Number: 0-047		Room Reference: Classroom		Review Date: 18-02-2020
	Asbestos Detected	Sample Reference	Asbestos Type	Product Type	Surface Treatment
	Asbestos Confirmed	As013	Chrysotile	Floor Tiles	Floor Tiles.
		Extent	Condition	Accessibility	Risk Score
	50-75m ²	0 - Good	Difficult	2

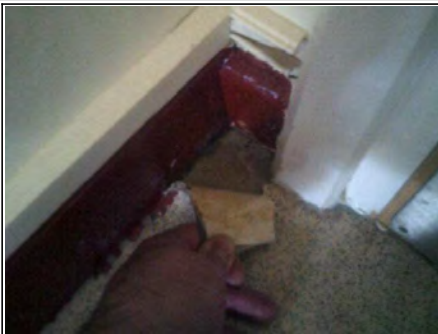
Room Number: 0-048		Room Reference: Classroom		Review Date: 18-02-2020
	Asbestos Detected	Sample Reference	Asbestos Type	Product Type	Surface Treatment
	Asbestos Confirmed	As013	Chrysotile	Floor Tiles	Floor Tiles.
		Extent	Condition	Accessibility	Risk Score
	50-75m ²	0 - Good	Difficult	2

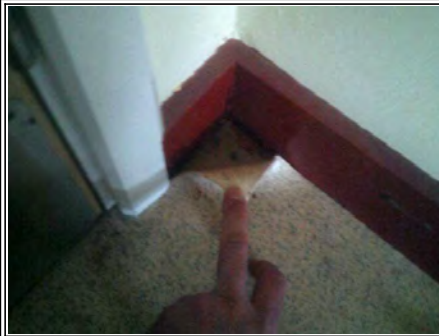
Asbestos Confirmed	Room Number: 0-051		Room Reference: Classroom		Review Date: 18-02-2020
	Asbestos Detected	Sample Reference	Asbestos Type	Product Type	Surface Treatment
		As013	Chrysotile	Floor Tiles	Floor Tiles.
	Extent	Condition	Accessibility	Risk Score	
	50-75m ²	0 - Good	Difficult	2	
	Comment:	The cream floor tiles beneath the carpet were seen to be in good condition at the time of the survey.			
Recommendation:	The condition of the floor tiles should be monitored.

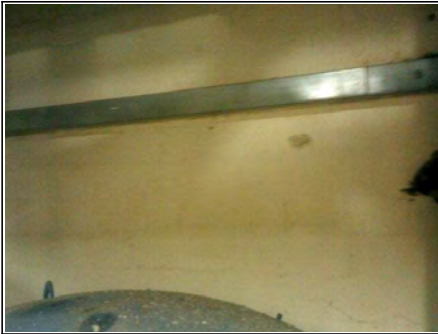
Room Number: 0-056		Room Reference: Boiler Room		Review Date: 18-02-2020
	Asbestos Detected	Sample Reference	Asbestos Type	Product Type	Surface Treatment
	Asbestos Confirmed	032	Amosite	Insulation (Sealed)	Sealed Pipe Insulation
		Extent	Condition	Accessibility	Risk Score
	30-40m ²	1 - Low Damage	Easy	7

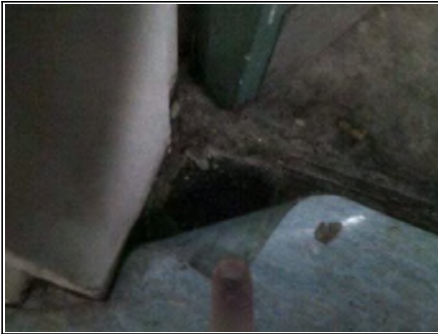
Room Number: 0-068		Room Reference: Corridor		Review Date: 18-02-2020
	Asbestos Detected	Sample Reference	Asbestos Type	Product Type	Surface Treatment
	Asbestos Confirmed	018	Chrysotile	Floor Tiles	Floor Tiles.
		Extent	Condition	Accessibility	Risk Score
	30-40m ²	0 - Good	Difficult	2

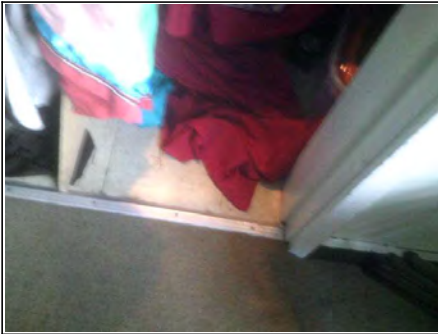
Room Number: 0-071		Room Reference: Store		Review Date: 18-02-2020
	Asbestos Detected	Sample Reference	Asbestos Type	Product Type	Surface Treatment
	Asbestos Confirmed	019	Chrysotile	Floor Tiles	Floor Tiles.
		Extent	Condition	Accessibility	Risk Score
		1-5m ²	0 - Good	Easy	2

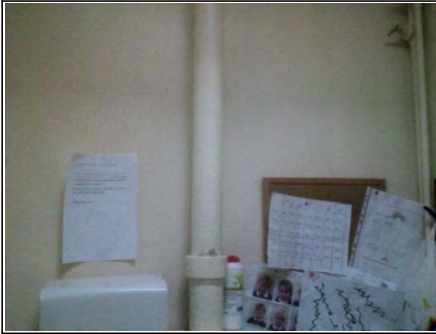
Room Number: 0-074		Room Reference: Staff Wash Area		Review Date: 18-02-2020
	Asbestos Detected	Sample Reference	Asbestos Type	Product Type	Surface Treatment
	Asbestos Confirmed	020	Chrysotile	Cement Flue Pipe	Sealed Cement
		Extent	Condition	Accessibility	Risk Score
		1-5LM	0 - Good	Difficult	3

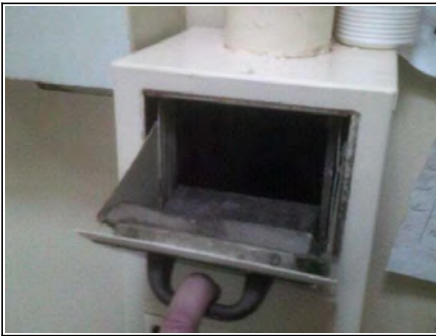
Room Number: 0-074		Room Reference: Staff Wash Area		Review Date: 18-02-2020
	Asbestos Detected	Sample Reference	Asbestos Type	Product Type	Surface Treatment
	Asbestos Confirmed	021	Chrysotile	Cement Panel(s)	Cement
		Extent	Condition	Accessibility	Risk Score
		Number x 01	0 - Good	Difficult	3

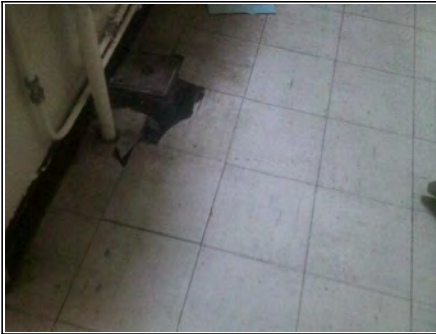
Room Number: 0-074		Room Reference: Staff Wash Area		Review Date: 18-02-2020
	Asbestos Detected	Sample Reference	Asbestos Type	Product Type	Surface Treatment
	Asbestos Confirmed	022	Chrysotile	Floor Tiles	Floor Tiles.
		Extent	Condition	Accessibility	Risk Score
	5-10m ²	1 - Low Damage	Easy	3

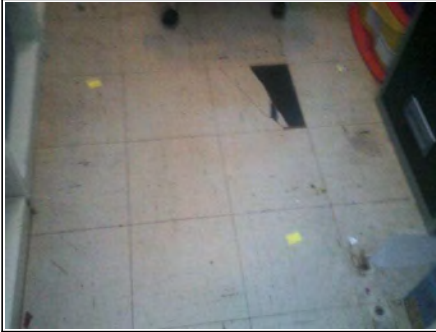
Room Number: 0-076		Room Reference: Store		Review Date: 18-02-2020
	Asbestos Detected	Sample Reference	Asbestos Type	Product Type	Surface Treatment
	Asbestos Confirmed	023	Chrysotile	Floor Tiles	Floor Tiles.
		Extent	Condition	Accessibility	Risk Score
	5-10m ²	1 - Low Damage	Easy	3

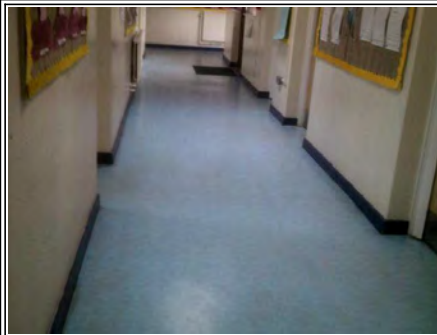
Room Number: 0-078		Room Reference: Corridor		Review Date: 18-02-2020
	Asbestos Detected	Sample Reference	Asbestos Type	Product Type	Surface Treatment
	Asbestos Confirmed	025	Chrysotile	Floor Tiles	Floor Tiles.
		Extent	Condition	Accessibility	Risk Score
		50-75m ²	0 - Good	Difficult	2
	Comment:	The brown floor tiles (including the bitumen adhesive) beneath vinyl were seen to be in good condition at the time of the survey.			
Recommendation:	The condition of the floor tiles should be monitored.

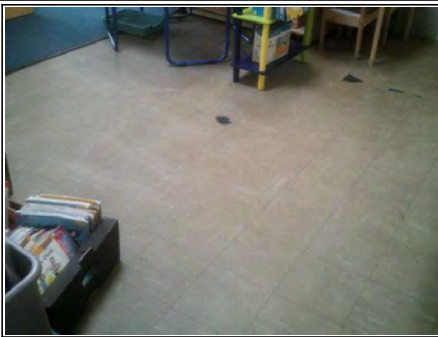
Room Number: 0-082		Room Reference: Classroom		Review Date: 18-02-2020
	Asbestos Detected	Sample Reference	Asbestos Type	Product Type	Surface Treatment
	Asbestos Confirmed	026	Chrysotile	Floor Tiles	Floor Tiles.
		Extent	Condition	Accessibility	Risk Score
	25-30m ²	0 - Good	Easy	2

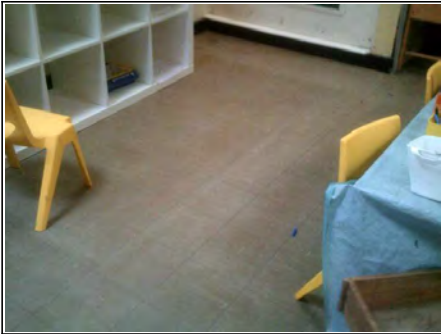
Room Number: 0-085		Room Reference: Resource Area		Review Date: 18-02-2020
	Asbestos Detected	Sample Reference	Asbestos Type	Product Type	Surface Treatment
	Asbestos Confirmed	As026	Chrysotile	Floor Tiles	Floor Tiles.
		Extent	Condition	Accessibility	Risk Score
	25-30m ²	0 - Good	Easy	2
