Asbestos Management Survey

Christ The King R C Primary School

A & L Reference : 28329
Building Reference : 344/2214

Allport Road
Bromborough
Wirral
CH62 6AE

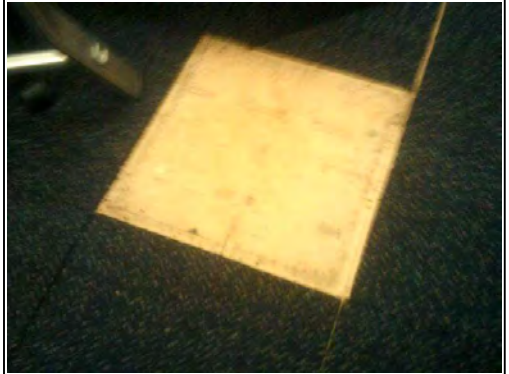
Ceilings: Plasterboard to wooden joists	Walls: Solid masonry with plaster skim	Floors: Concrete beneath floor tiles and carpet tiles	Other: N/A

Asbestos Confirmed

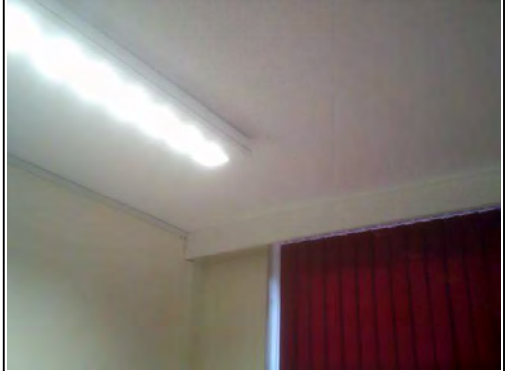
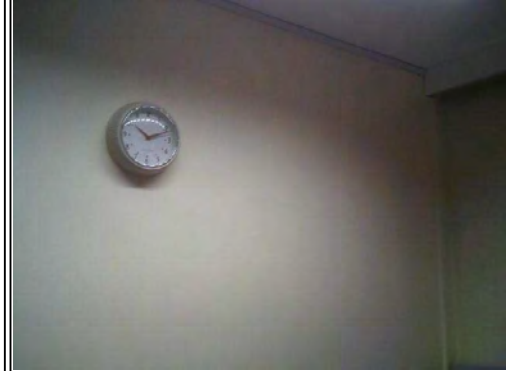
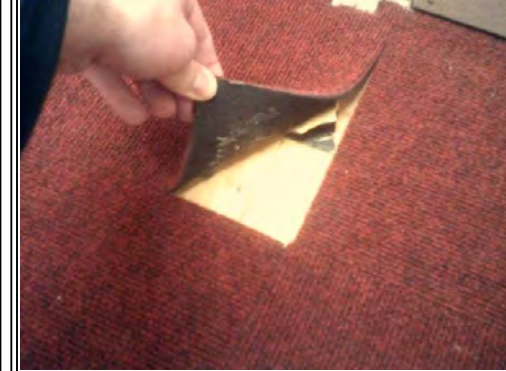
Ceilings: Plasterboard to wooden joists	Walls: Solid masonry with plaster skim	Floors: Concrete beneath floor tiles and carpet tiles	Other: N/A

Asbestos Confirmed

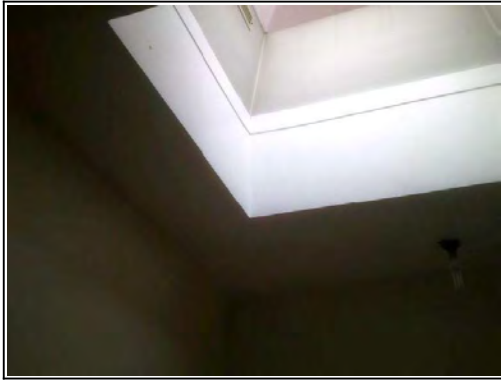
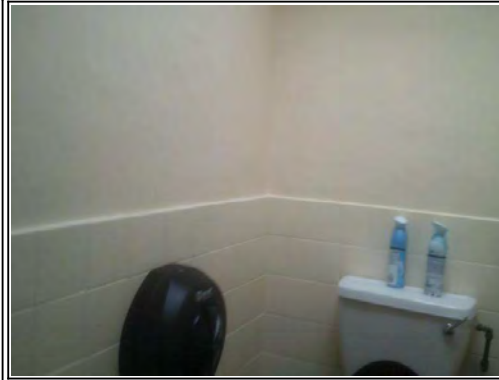
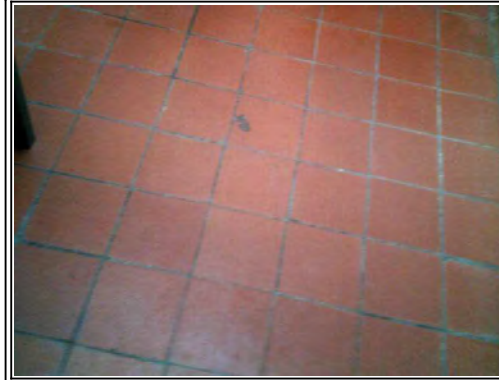
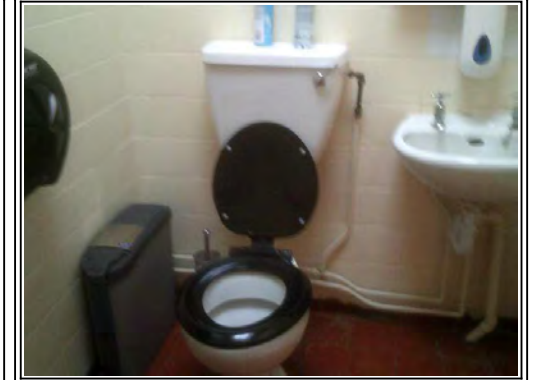
Asbestos Confirmed

Asbestos containing materials have been identified in this area. Please see the full asbestos register for further details.

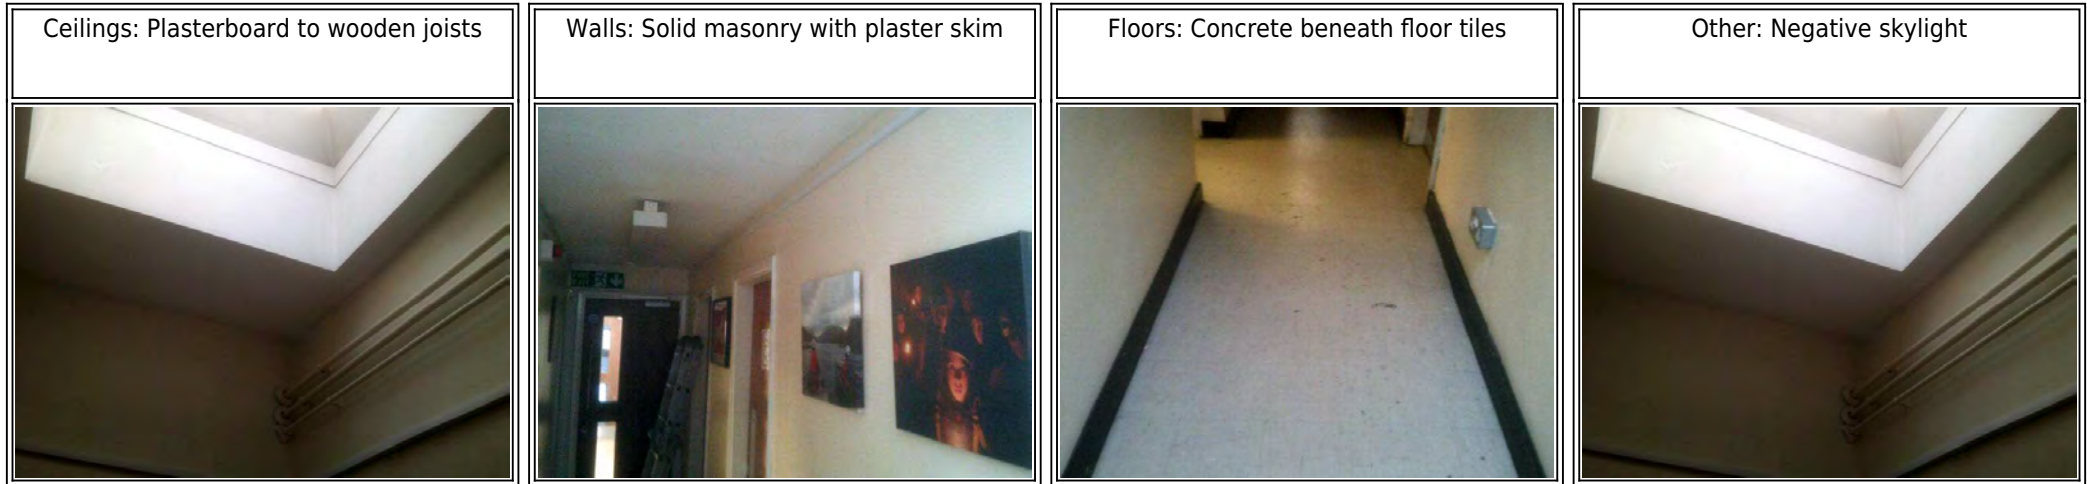
Room 0-010 - Corridor

0-010 Corridor Floor Tiles	2	The cream floor tiles were seen to be in good condition at the time of the survey.	The condition of the floor tiles should be monitored.
0-018 Store Cement Panel(s)	3	The cement panels to the walls and ceiling were seen to be sealed and in good condition at the time of the survey.	The cement panels should be labelled accordingly and their condition should continue to be monitored.
0-037 Lobby Bitumen Adhesive	3	The bitumen adhesive under the floor tiles was seen to be enclosed with areas of low damage at the time of the survey.	The floor tiles (including the bitumen adhesive) should be repaired or removed under controlled conditions and disposed of as asbestos waste.
0-038 Under Stair Store Bitumen Adhesive	3	The bitumen adhesive under the floor tiles was seen to be enclosed with areas of low damage at the time of the survey.	The floor tiles (including the bitumen adhesive) should be repaired or removed under controlled conditions and disposed of as asbestos waste.

Asbestos Confirmed

Asbestos containing materials have been identified in this area. Please see the full asbestos register for further details.

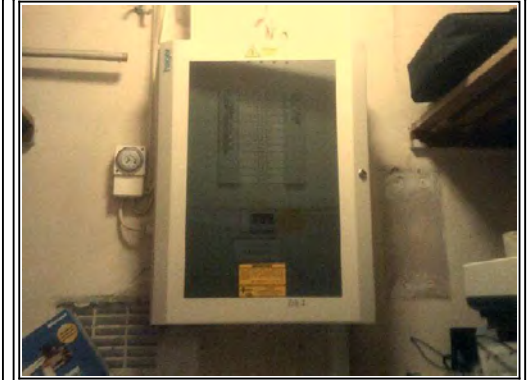
Other: Negative electrics

No Asbestos

No asbestos containing materials identified in this area.

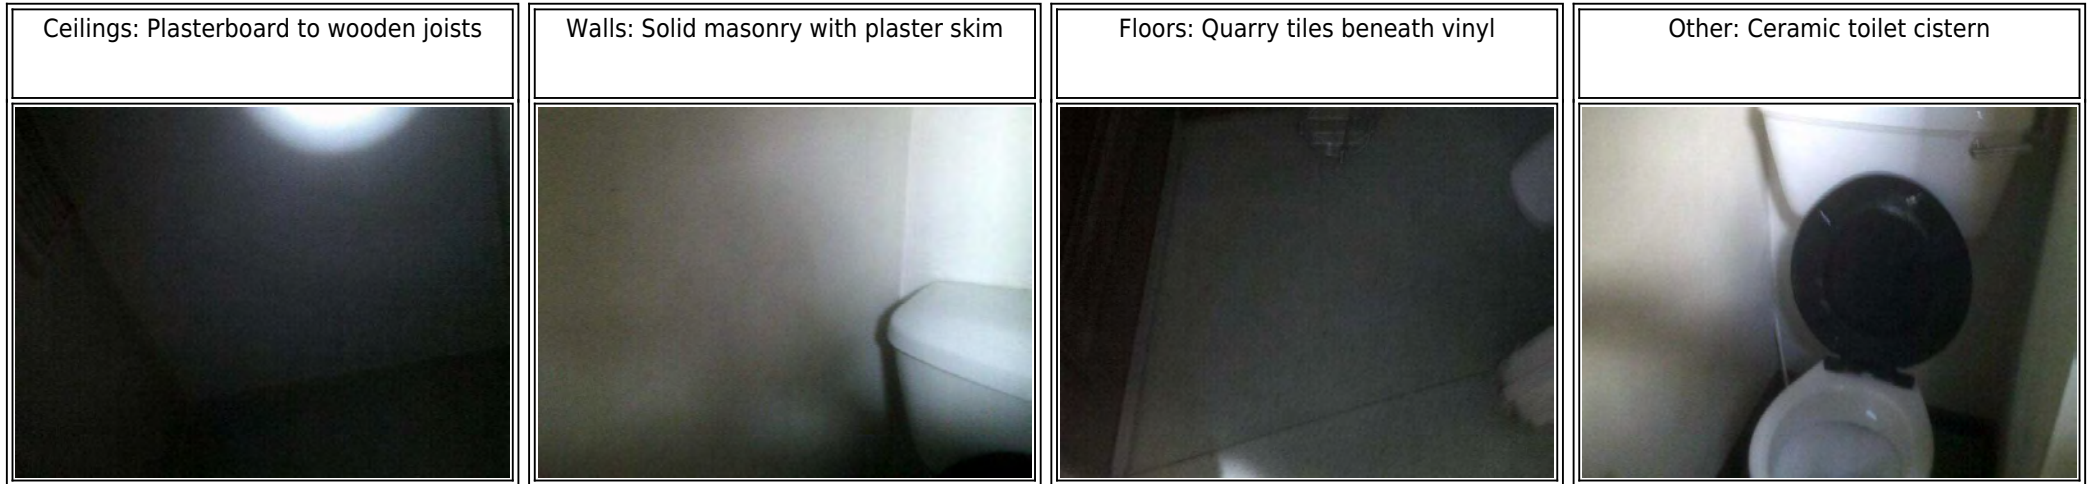
Room 0-016 - Toilet

No Asbestos

No asbestos containing materials identified in this area.

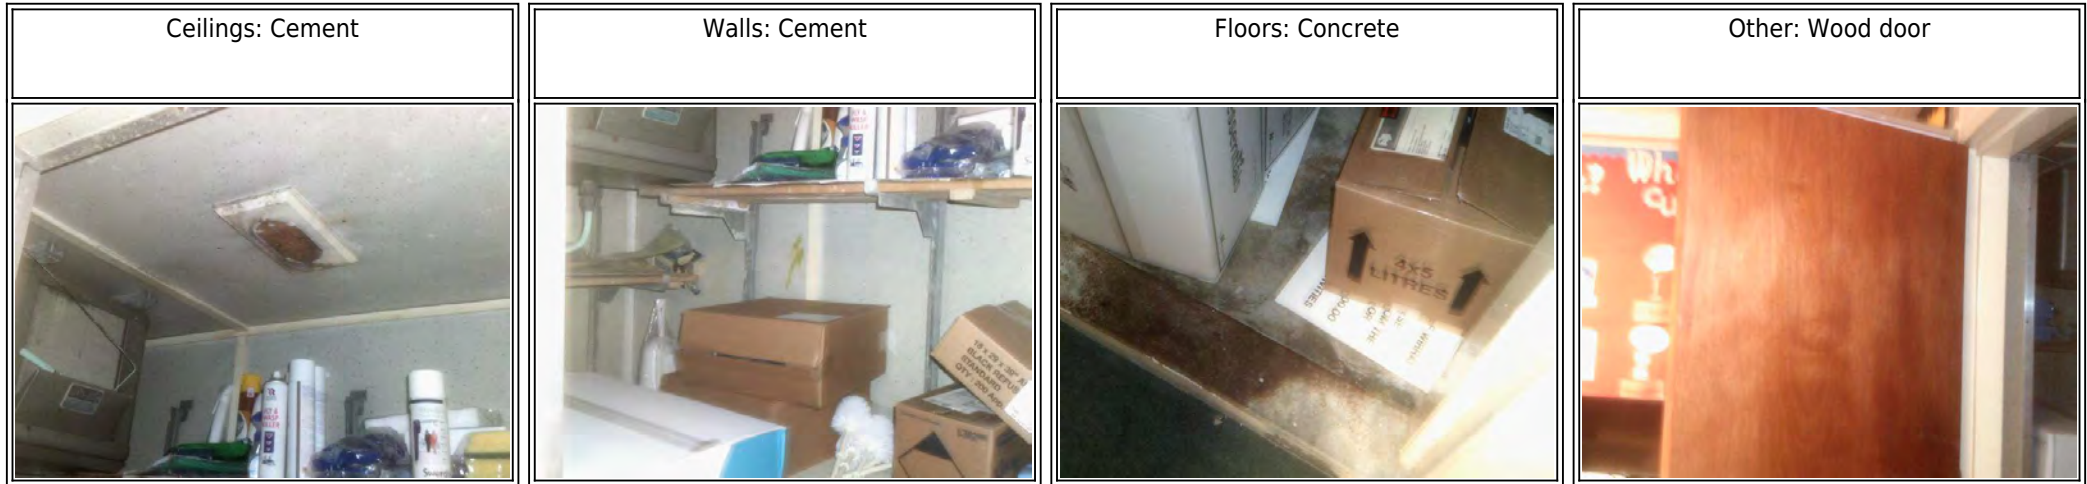
Room 0-018 - Store

Asbestos Confirmed

Asbestos containing materials have been identified in this area. Please see the full asbestos register for further details.

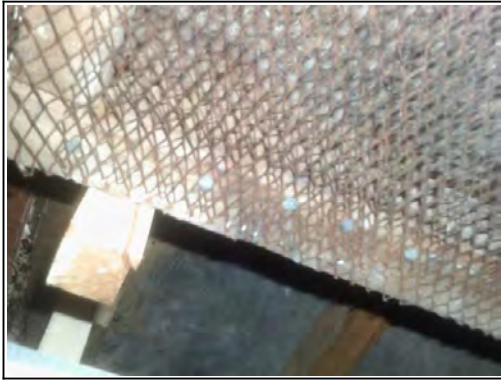
Ceilings: Strawboard above plasterboard and white mosh

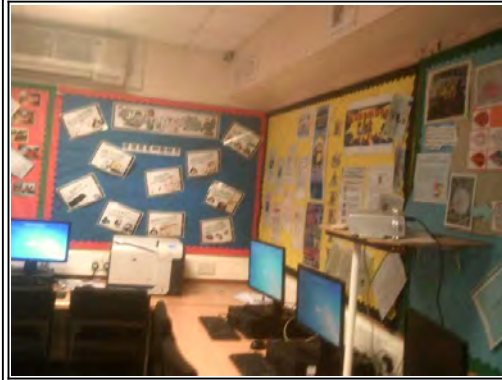
Walls: Solid masonry with plaster skim

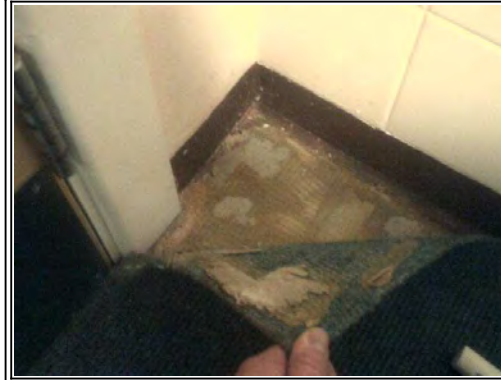
Floors: Quarry tiles

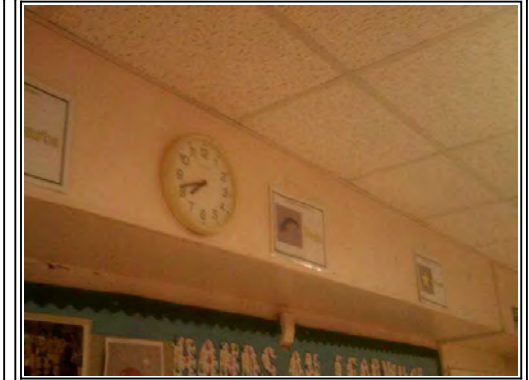
Other: Wood boxing to pipework

No Asbestos

No asbestos containing materials identified in this area.

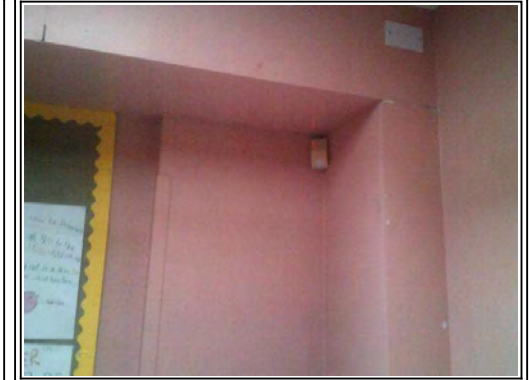
Other: Wood boxing to pipework and negative skylights

No Asbestos

No asbestos containing materials identified in this area.

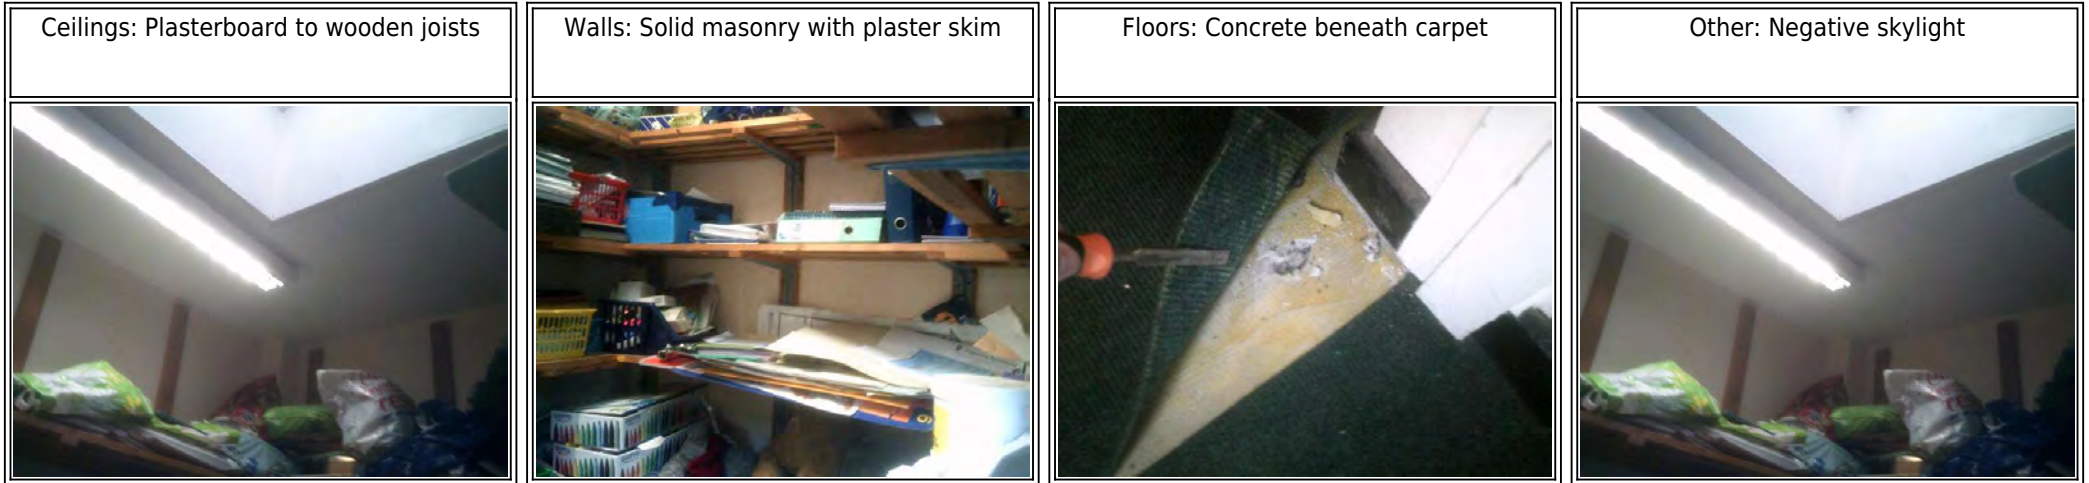
Room 0-024 - Store

No Asbestos

No asbestos containing materials identified in this area.

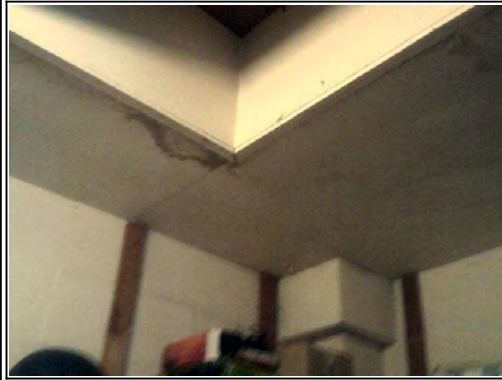
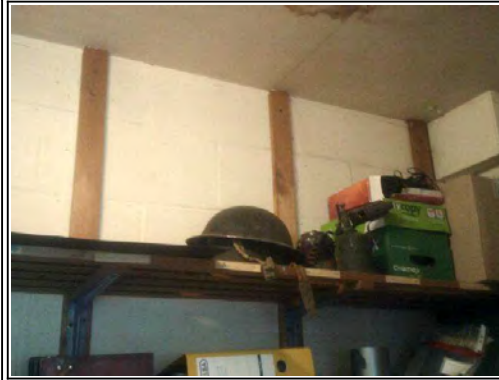
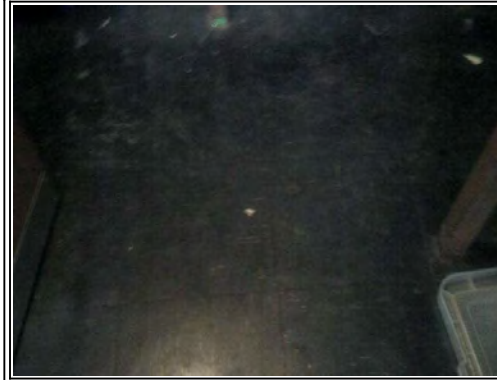
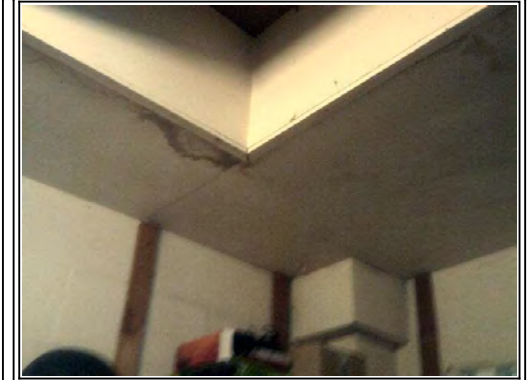
Room 0-029 - Store

No asbestos containing materials identified in this area.

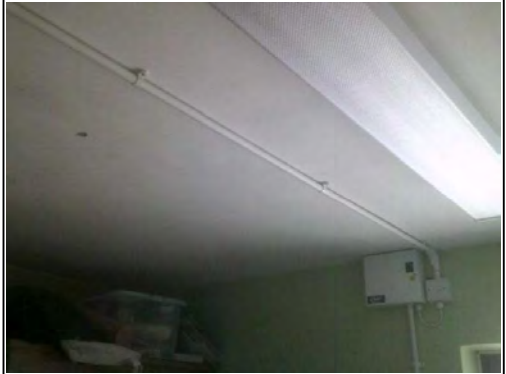
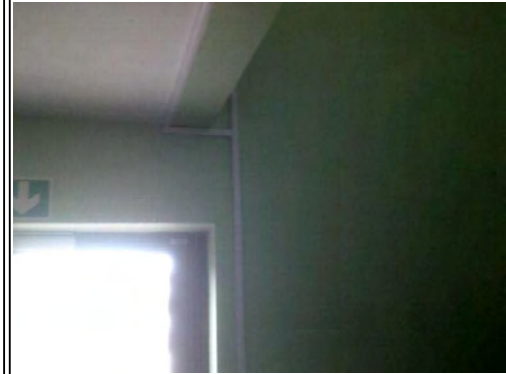
Ceilings: Plasterboard to wooden joists	Walls: Solid masonry with plaster skim	Floors: Concrete beneath floor tiles	Other: N/A

Asbestos Confirmed

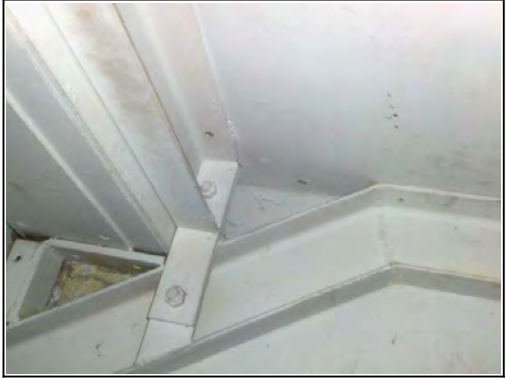
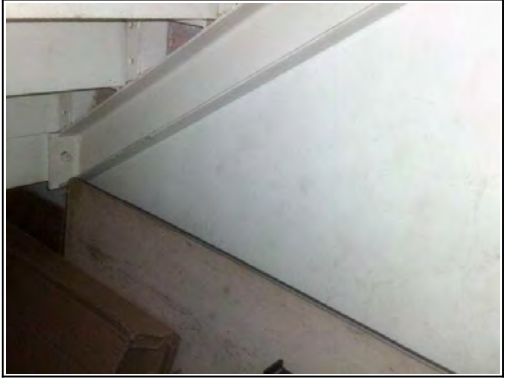
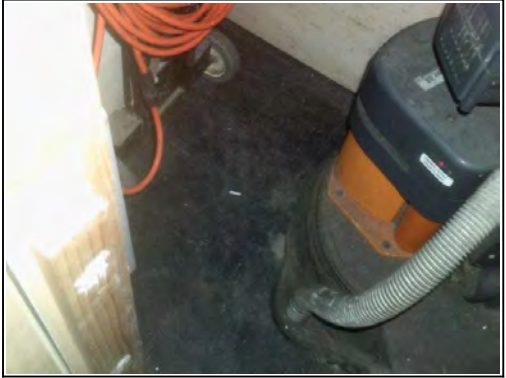
Ceilings: Metal/wood	Walls: Plasterboard	Floors: Concrete beneath floor tiles	Other: N/A

Asbestos Confirmed

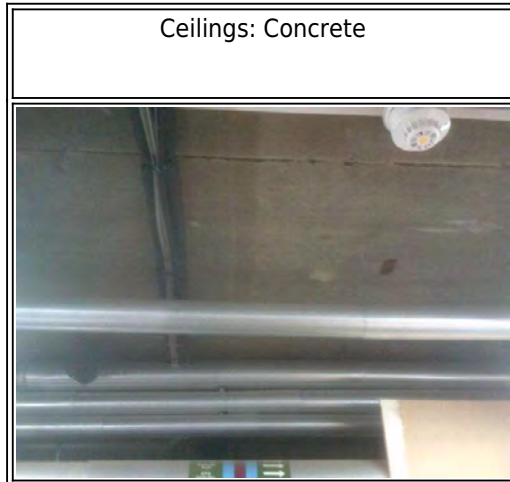
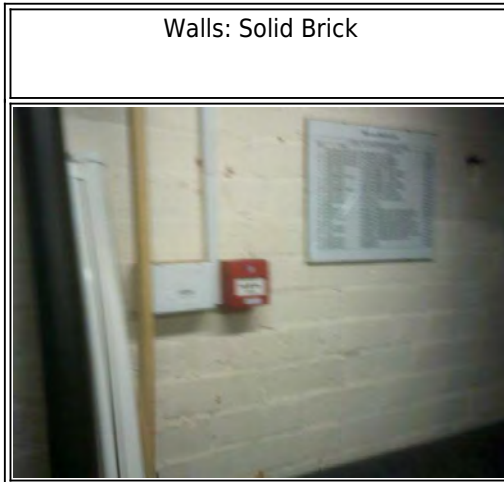
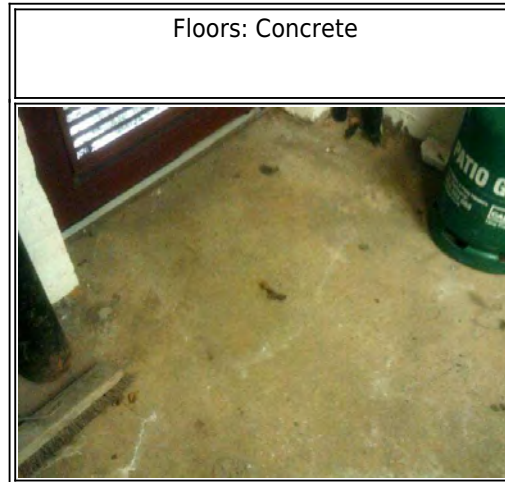
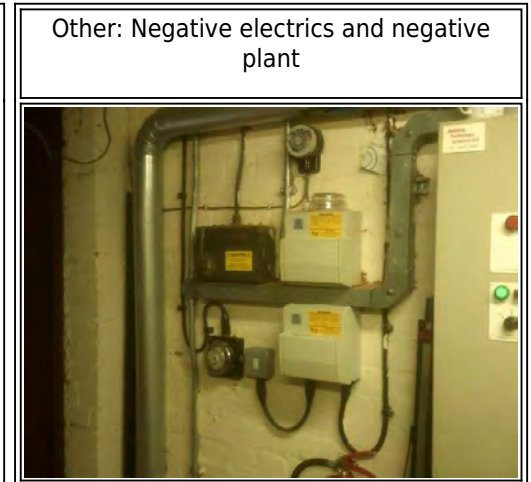
Room 0-056 - Boiler Room

Asbestos Confirmed

Asbestos containing materials have been identified in this area. Please see the full asbestos register for further details.

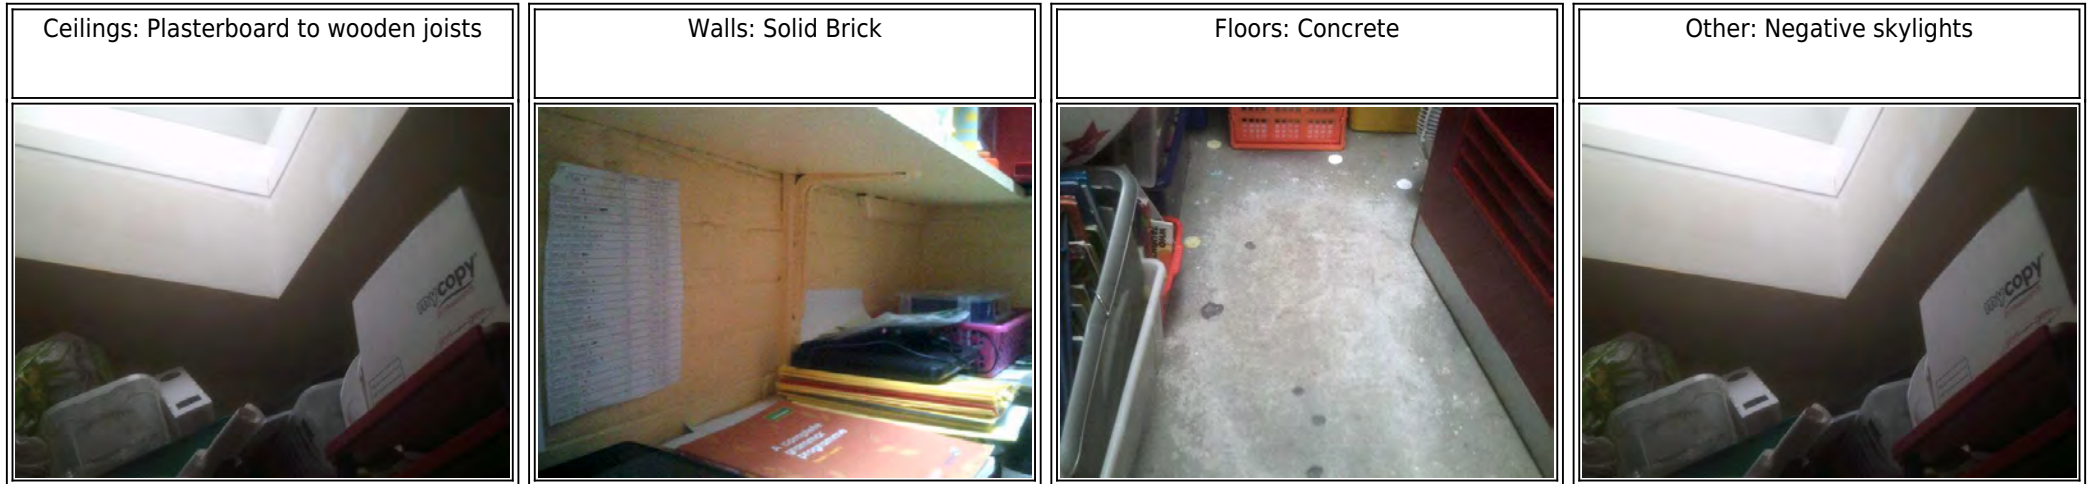
Room 0-058 - Store

No Asbestos

No asbestos containing materials identified in this area.

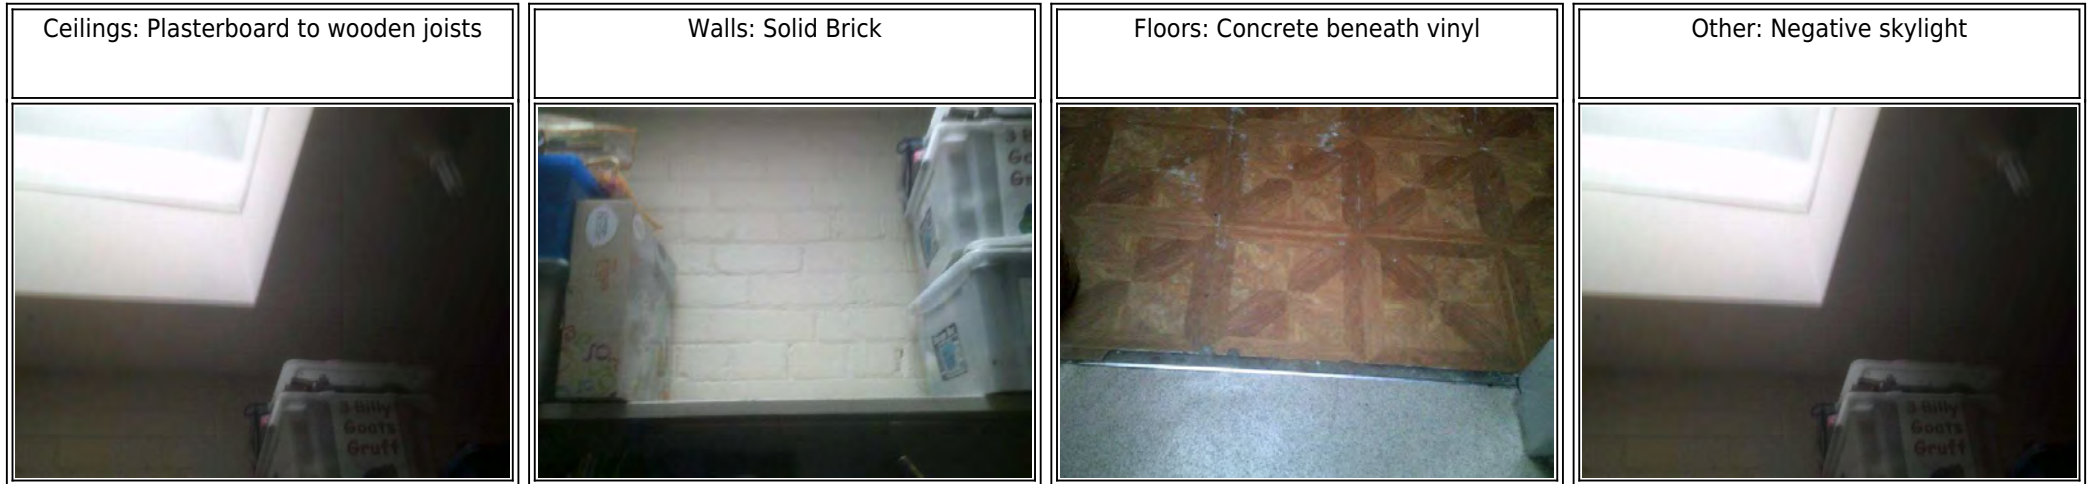
Room 0-065 - Store

No Asbestos

No asbestos containing materials identified in this area.

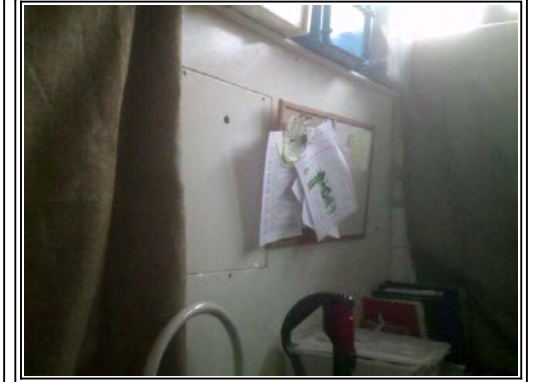
Other: Wood boxing to pipework

No Asbestos

No asbestos containing materials identified in this area.

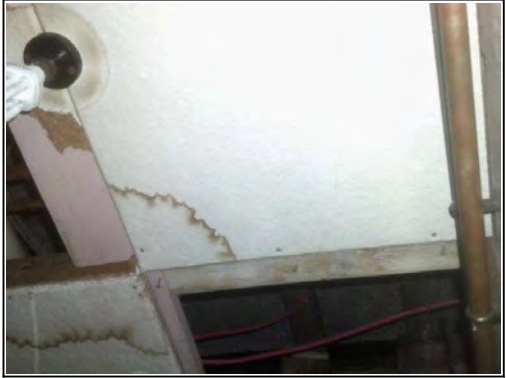
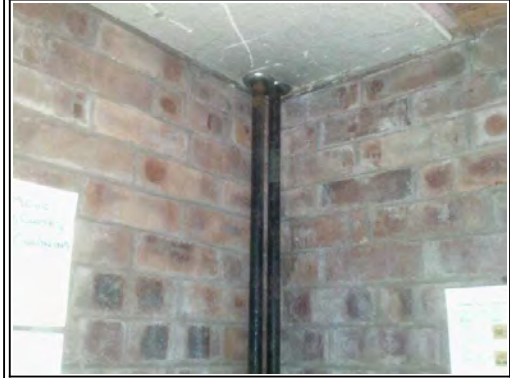
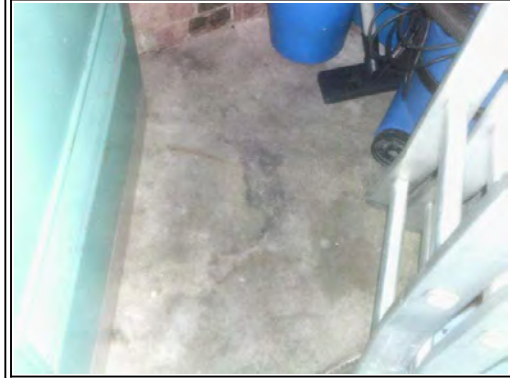
Ceilings: Sampled insulating board	Walls: Solid Brick	Floors: Concrete	Other: N/A

No Asbestos

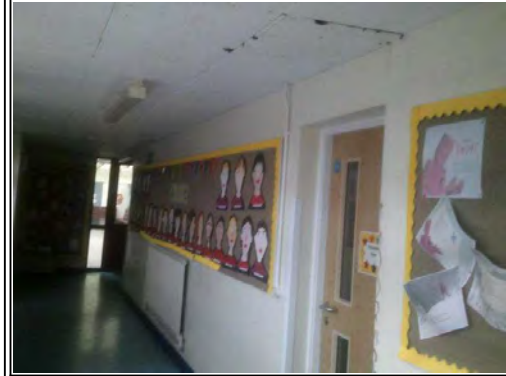
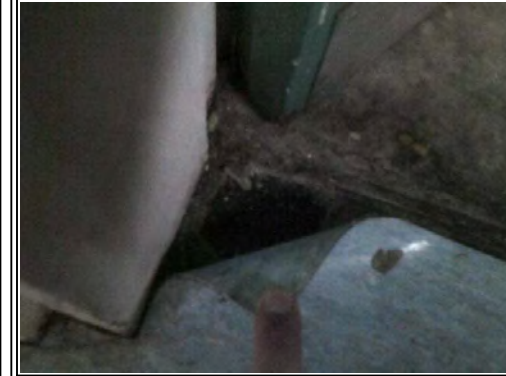
Ceilings: Insulating board	Walls: Solid masonry with plaster skim	Floors: Concrete beneath floor tiles and vinyl	Other: N/A

Asbestos Confirmed

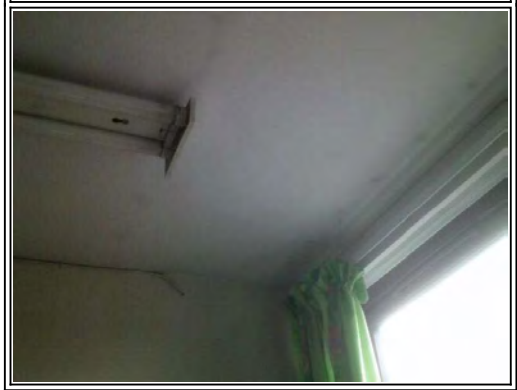
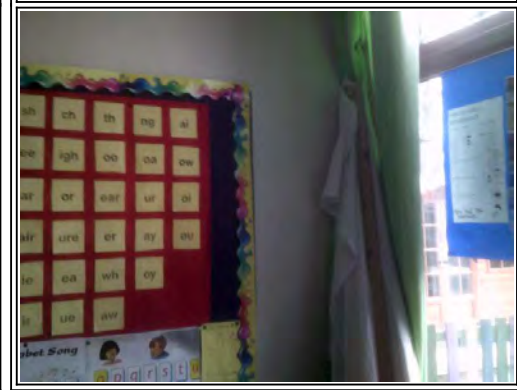
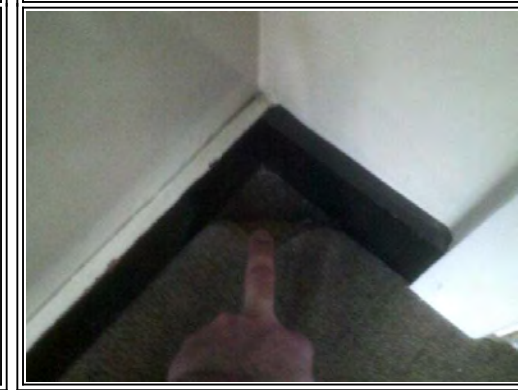
Ceilings: Plasterboard to wooden joists	Walls: Solid masonry with plaster skim	Floors: Concrete beneath carpet	Other: N/A

No Asbestos

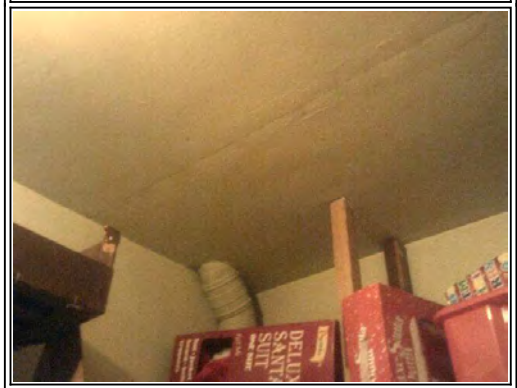
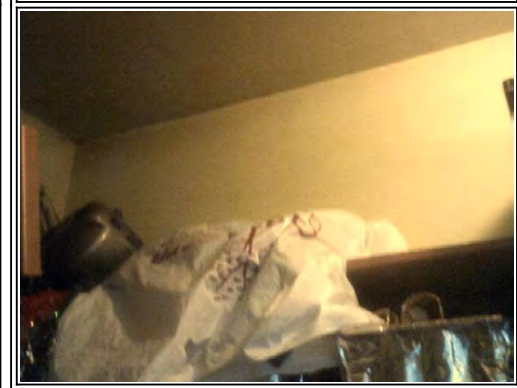
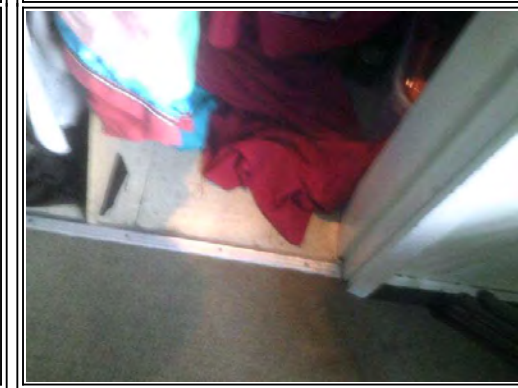
Ceilings: Plasterboard to wooden joists	Walls: Solid masonry with plaster skim	Floors: Concrete beneath floor tiles	Other: N/A

Asbestos Confirmed

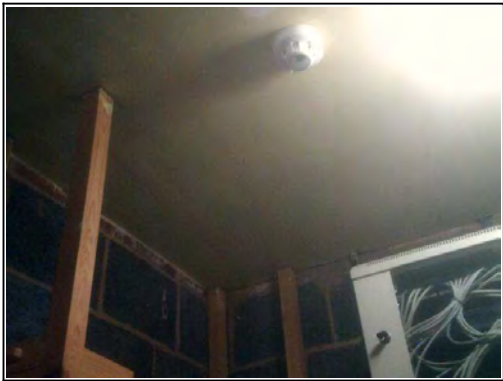
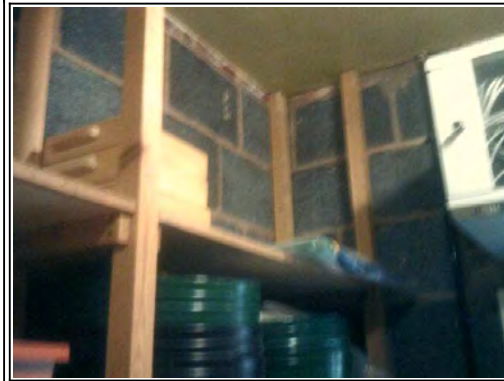
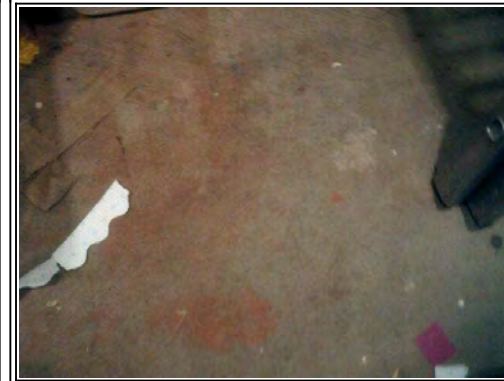
Ceilings: Plasterboard to wooden joists	Walls: Solid Block	Floors: Concrete	Other: N/A

No Asbestos

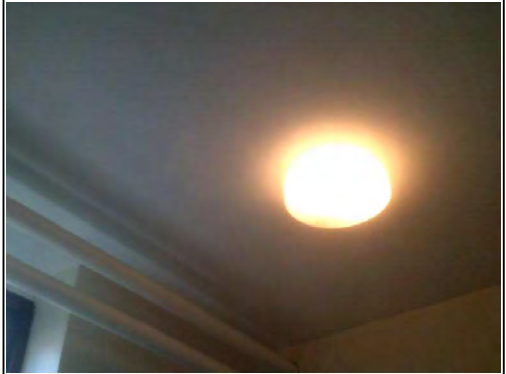
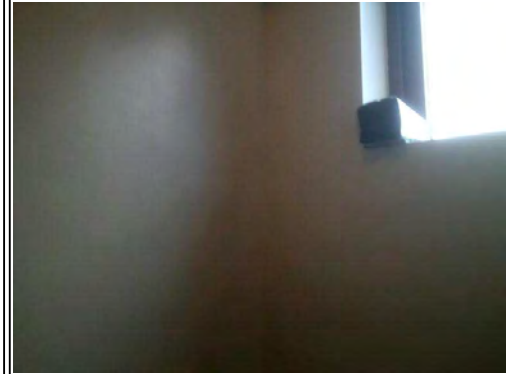
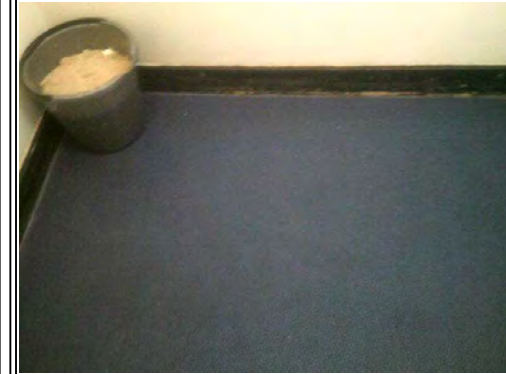
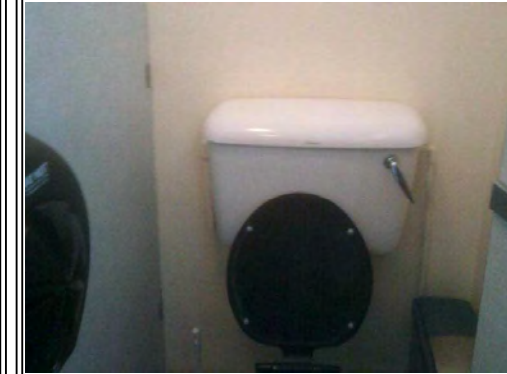
Ceilings: Plasterboard to wooden joists	Walls: Solid masonry with plaster skim	Floors: Concrete beneath vinyl	Other: Ceramic toilet cistern x 2

No Asbestos

No asbestos containing materials identified in this area.

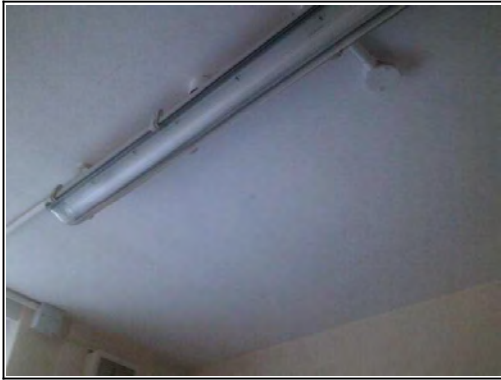
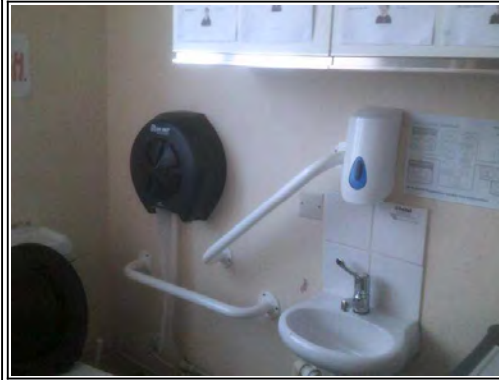
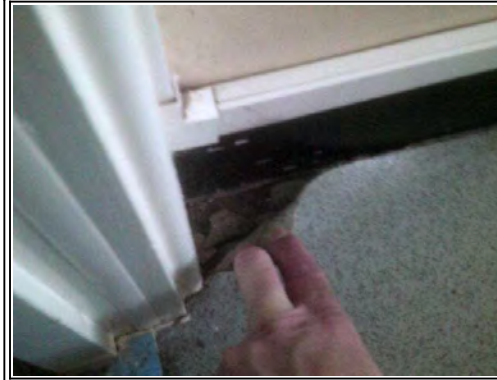
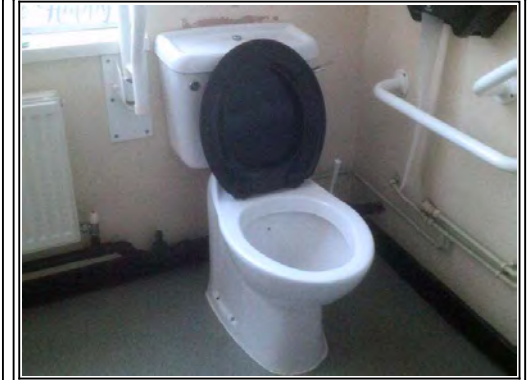
Ceilings: Plasterboard to wooden joists

Walls: Solid masonry with plaster skim

Floors: Concrete beneath vinyl

Other: Ceramic toilet cistern

No Asbestos

No asbestos containing materials identified in this area.

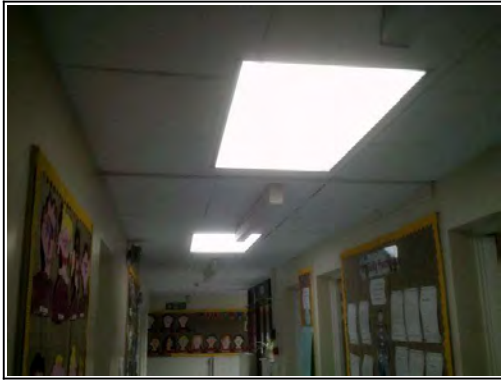
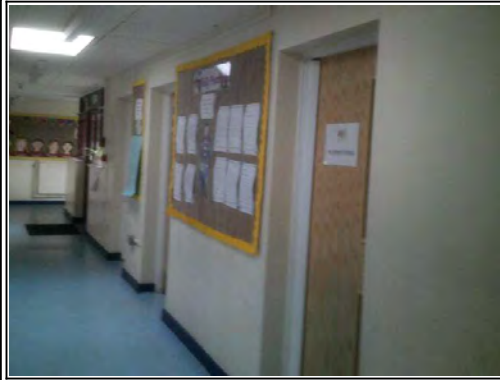
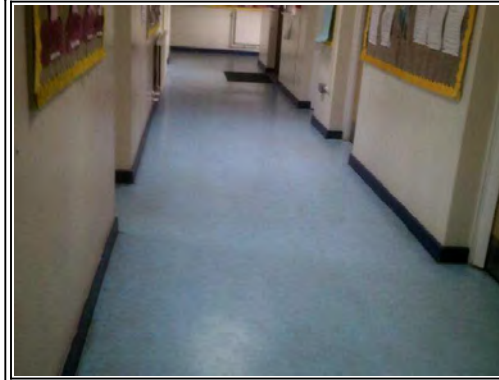
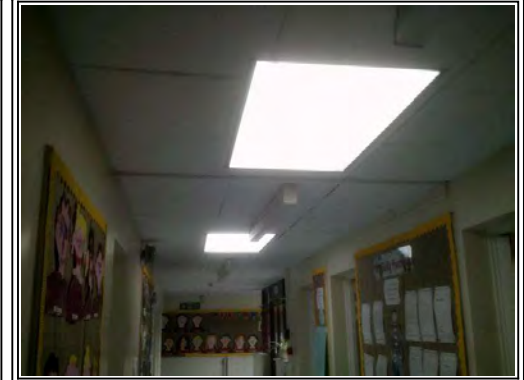
Ceilings: Insulating board

Walls: Solid masonry with plaster skim

Floors: Concrete beneath floor tiles and carpet

Other: Negative skylight

Asbestos Confirmed

Asbestos containing materials have been identified in this area. Please see the full asbestos register for further details.

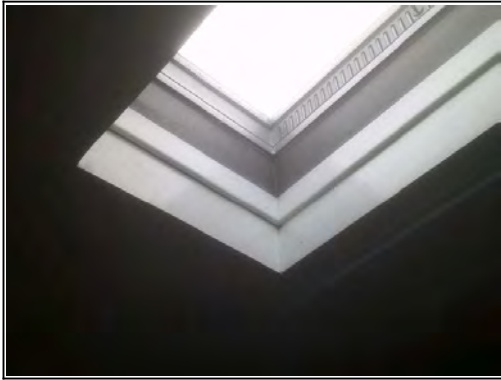
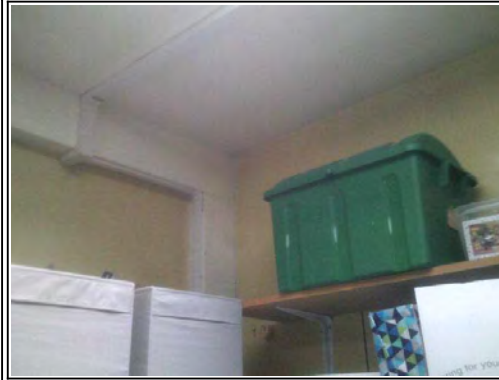
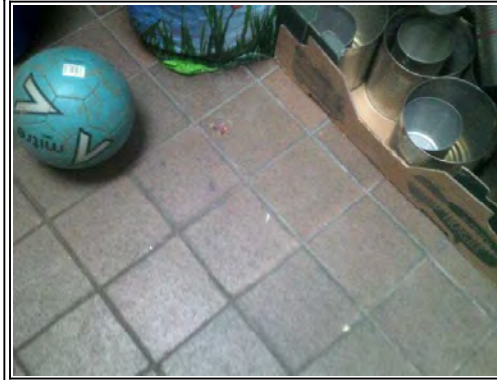
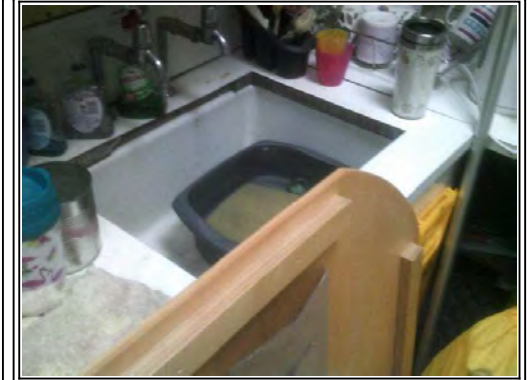
Ceilings: Plasterboard to wooden joists

Walls: Solid masonry with plaster skim

Floors: Quarry tiles

Other: Negative sink unit

No Asbestos

No asbestos containing materials identified in this area.

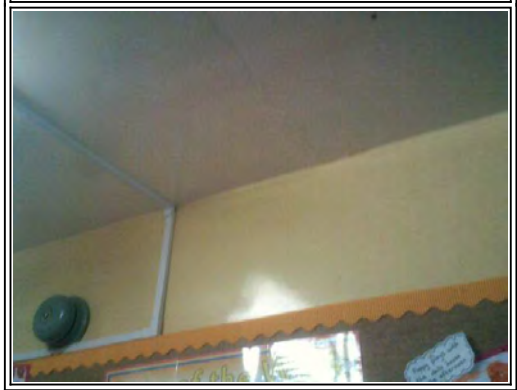
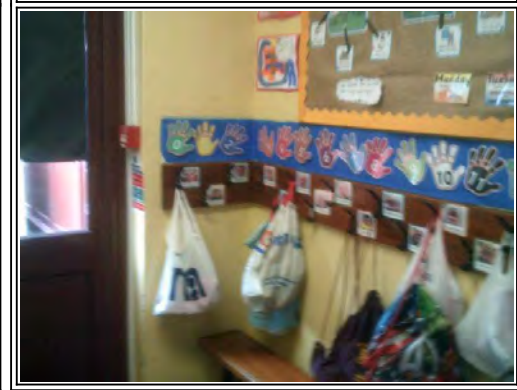
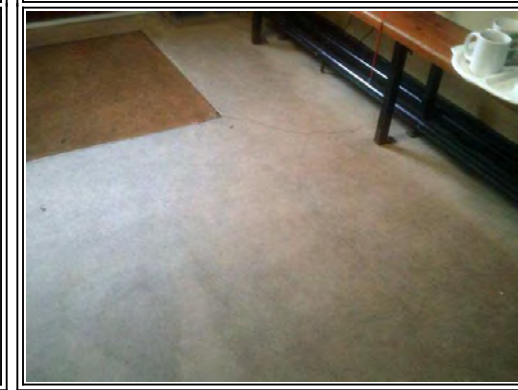
Ceilings: Plasterboard to wooden joists	Walls: Solid masonry with plaster skim	Floors: Concrete	Other: N/A

No Asbestos

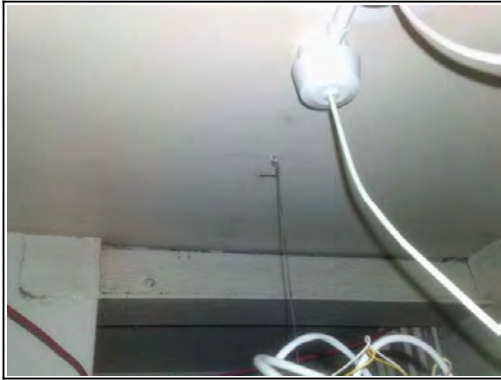
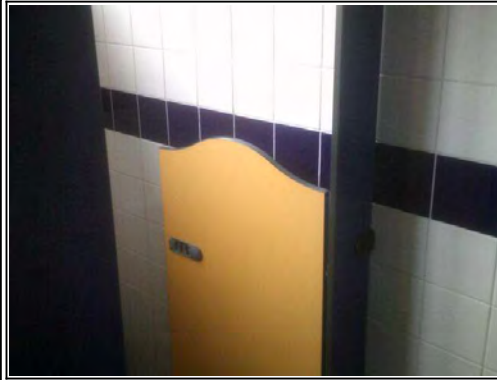
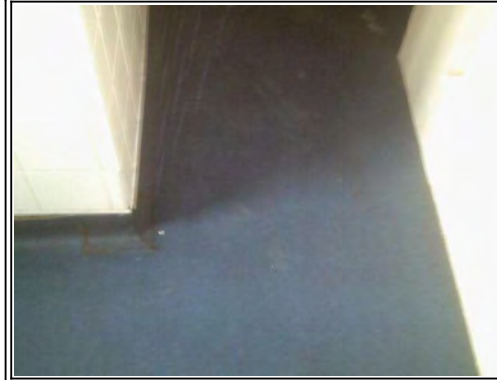
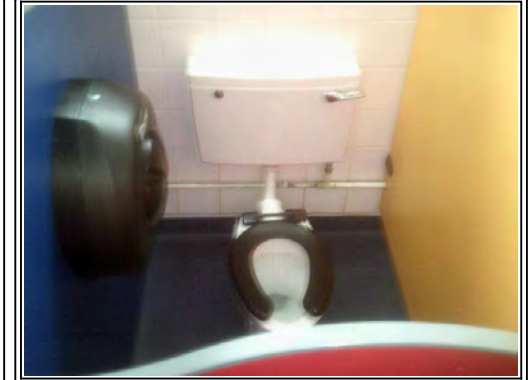
Ceilings: Plasterboard above suspended ceiling

Walls: Solid masonry behind ceramic tiles

Floors: Concrete beneath vinyl

Other: 3 x plastic toilet cistern

No Asbestos

No asbestos containing materials identified in this area.

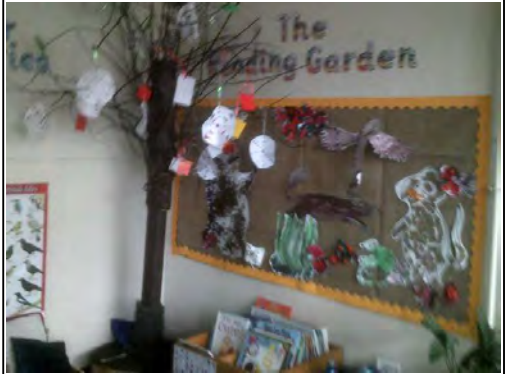
Ceilings: Plasterboard to wooden joists	Walls: Solid masonry and plasterboard partitions with plaster skim	Floors: Concrete beneath carpet	Other: N/A

No Asbestos

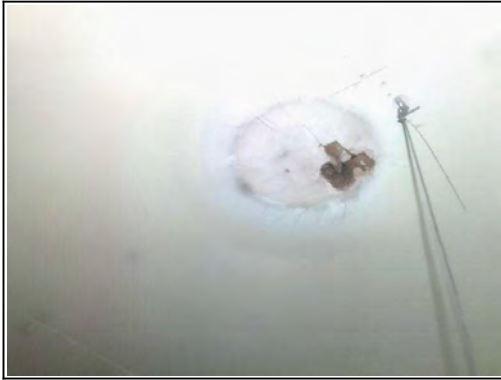
Ceilings: Plasterboard above suspended ceiling

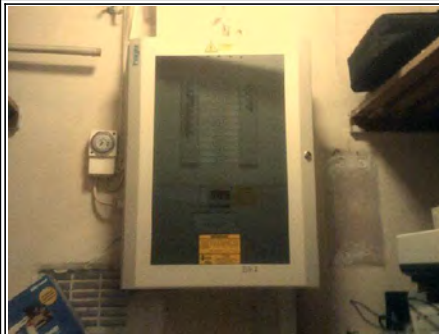
NO SUSPECT MATERIALS SEEN	Room Number: 0-012		Room Reference: Cupboard		Review Date:
	Asbestos Detected	Sample Reference	Asbestos Type	Product Type	Surface Treatment
	No Asbestos Detected				
		Extent	Condition	Accessibility	Risk Score
					0
	Comment:	No suspect asbestos containing materials were seen in the area during the course of the survey.			
Recommendation:	No further action required.

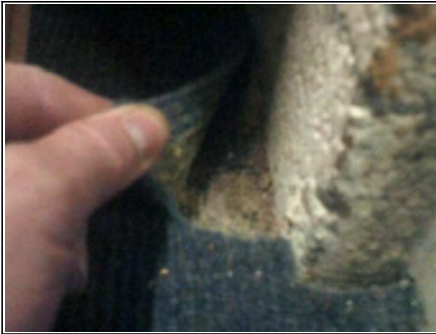
Room Number: 0-021		Room Reference: Store		Review Date:
	Asbestos Detected	Sample Reference	Asbestos Type	Product Type	Surface Treatment
	No Asbestos Detected	006		Floor Tiles	
		Extent	Condition	Accessibility	Risk Score
		5-10m ²			0

Comment:	No asbestos was detected in the sample of the black floor tiles beneath the carpet ref: 28329/006.			
Recommendation:	No further action required.

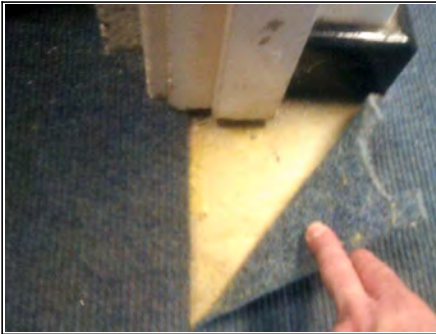
Room Number: 0-022		Room Reference: Classroom		Review Date:
	Asbestos Detected	Sample Reference	Asbestos Type	Product Type	Surface Treatment
	No Asbestos Detected	As006		Floor Tiles	
		Extent	Condition	Accessibility	Risk Score
		50-75m ²			0

Comment:	No asbestos was detected in the sample of the black floor tiles beneath the carpet ref: 28329/006.			
Recommendation:	No further action required.

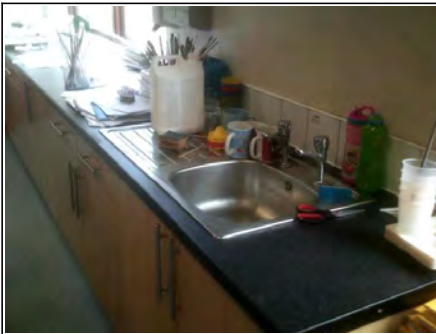
Room Number: 0-022		Room Reference: Classroom		Review Date:
	Asbestos Detected	Sample Reference	Asbestos Type	Product Type	Surface Treatment
	No Asbestos Detected	007		Bitumen Sink Pad	
		Extent	Condition	Accessibility	Risk Score
		Number x 01			0

Comment:	No asbestos was detected in the sample of the bitumen sink pad to the underside of the sink unit ref: 28329/007.			
Recommendation:	No further action required.

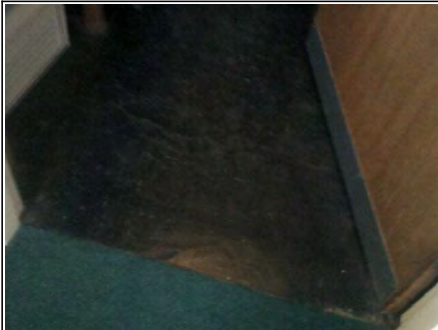
Room Number: 0-027		Room Reference: Store		Review Date:
	Asbestos Detected	Sample Reference	Asbestos Type	Product Type	Surface Treatment
	No Asbestos Detected	008		Floor Tiles	
		Extent	Condition	Accessibility	Risk Score
		5-10m ²			0
	Comment:	No asbestos was detected in the sample of the black floor tiles ref: 28329/008.			
Recommendation:	No further action required.

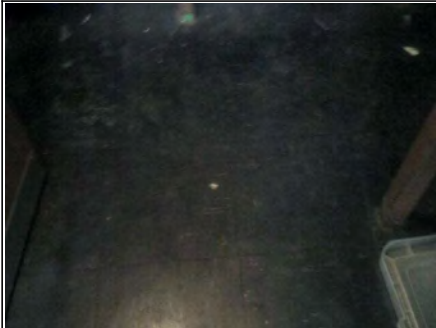
Room Number: 0-029		Room Reference: Store		Review Date:
	Asbestos Detected	Sample Reference	Asbestos Type	Product Type	Surface Treatment
	No Asbestos Detected	As008		Floor Tiles	
		Extent	Condition	Accessibility	Risk Score
		5-10m ²			0
	Comment:	No asbestos was detected in the sample of the black floor tiles ref: 28329/008.			
Recommendation:	No further action required.

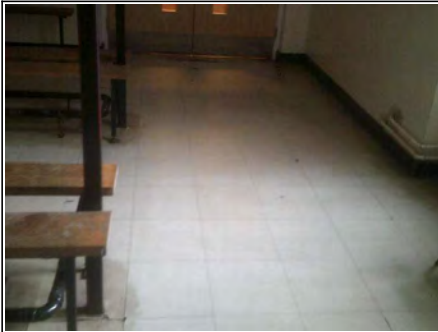
Room Number: 0-036		Room Reference: Corridor/Cloakroom		Review Date:
	Asbestos Detected	Sample Reference	Asbestos Type	Product Type	Surface Treatment
	No Asbestos Detected	009			Floor Tiles
		Extent	Condition	Accessibility	Risk Score
		30-40m ²			0

Comment: No asbestos was detected in the sample of the cream floor tiles ref: 28329/009.				
Recommendation: No further action required.

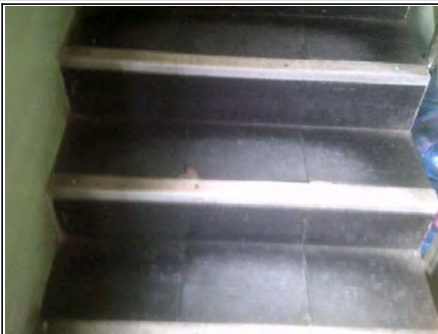
Room Number: 0-037		Room Reference: Lobby		Review Date:
	Asbestos Detected	Sample Reference	Asbestos Type	Product Type	Surface Treatment
	No Asbestos Detected	011		Stair Nosing	
		Extent	Condition	Accessibility	Risk Score
	Number x 10-15			0

Comment:	No asbestos was detected in the sample of the white stair nosing strips to the stairs ref: 28329/011.			
Recommendation:	No further action required.

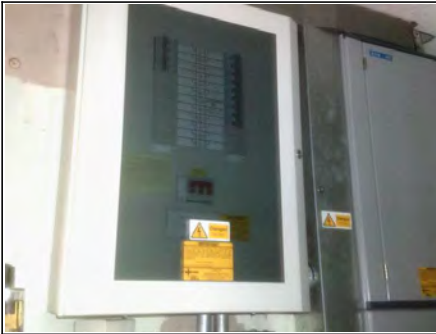
Room Number: 0-042		Room Reference: Caretakers Office		Review Date:
	Asbestos Detected	Sample Reference	Asbestos Type	Product Type	Surface Treatment
	No Asbestos Detected	Negative Electrics		Negative Electrics	
		Extent	Condition	Accessibility	Risk Score
				0
