Asbestos Management Survey

Christ The King R C Primary School

A & L Reference : 28329
Building Reference : 344/2214

Allport Road
Bromborough
Wirral
CH62 6AE

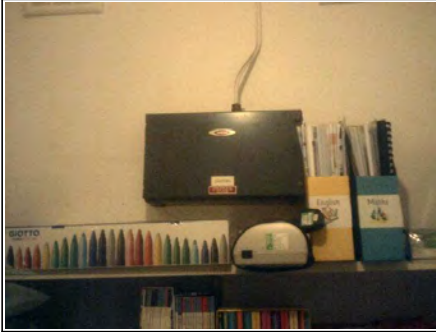
Room Number: 0-046		Room Reference: Store Room		Review Date:
	Asbestos Detected	Sample Reference	Asbestos Type	Product Type	Surface Treatment
	No Asbestos Detected	Negative Electrics		Negative Electrics	
		Extent	Condition	Accessibility	Risk Score
				0

Comment:	The electrical system within the area was seen to be of a type non conducive to containing asbestos containing materials and no further suspect asbestos containing materials were seen in the area at the time of the survey.				
Recommendation:	No further action required.

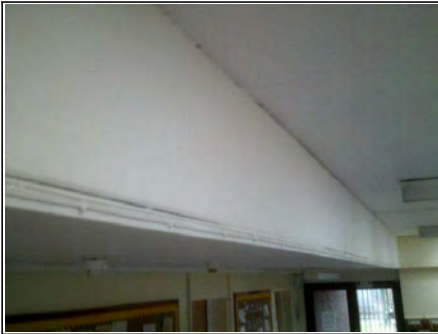
Room Number: 0-054		Room Reference: Corridor		Review Date:
	Asbestos Detected	Sample Reference	Asbestos Type	Product Type	Surface Treatment
	No Asbestos Detected	014		Insulating Board (Sealed)	
		Extent	Condition	Accessibility	Risk Score
		15-20m ²			0

Comment:	No asbestos was detected in the sample of the insulating boards (upstand) to the dropped / raised ceiling ref: 28329/014.				
Recommendation:	No further action required.				
NO SUSPECT MATERIALS SEEN	Room Number: 0-055		Room Reference: Store		Review Date:
	Asbestos Detected	Sample Reference	Asbestos Type	Product Type	Surface Treatment
	No Asbestos Detected				
		Extent	Condition	Accessibility	Risk Score
					0

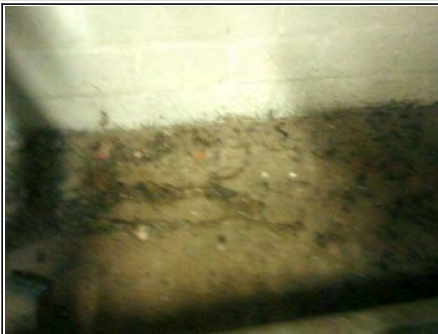
Room Number: 0-056		Room Reference: Boiler Room		Review Date:
	Asbestos Detected	Sample Reference	Asbestos Type	Product Type	Surface Treatment
	No Asbestos Detected	033		Debris	
		Extent	Condition	Accessibility	Risk Score
	Small Amounts			0

Comment:	No asbestos was detected in the sample of dust and debris to the floor ref: 28329/033.				
Recommendation:	No further action required.

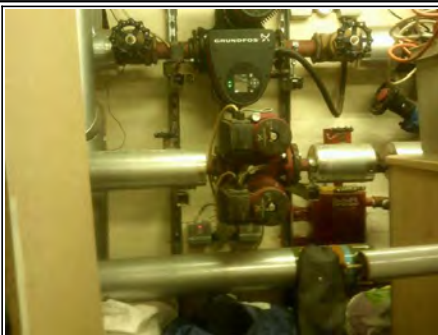
Room Number: 0-056		Room Reference: Boiler Room		Review Date:
	Asbestos Detected	Sample Reference	Asbestos Type	Product Type	Surface Treatment
	No Asbestos Detected	034		Gaskets	
		Extent	Condition	Accessibility	Risk Score
	Throughout			0

Comment:	No asbestos was detected in the sample of the gaskets to the pipe work ref: 28329/034.				
Recommendation:	No further action required.

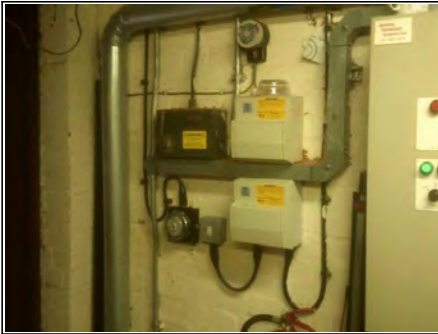
Room Number: 0-056		Room Reference: Boiler Room		Review Date:
	Asbestos Detected	Sample Reference	Asbestos Type	Product Type	Surface Treatment
	No Asbestos Detected	Negative Electrics		Negative Electrics	
		Extent	Condition	Accessibility	Risk Score
					0

Comment:	The electrical system within the area was seen to be of a type non conducive to containing asbestos containing materials.			
Recommendation:	No further action required.				
NO SUSPECT MATERIALS SEEN	Room Number: 0-057		Room Reference: Toilet		Review Date:
	Asbestos Detected	Sample Reference	Asbestos Type	Product Type	Surface Treatment
	No Asbestos Detected				
		Extent	Condition	Accessibility	Risk Score
					0

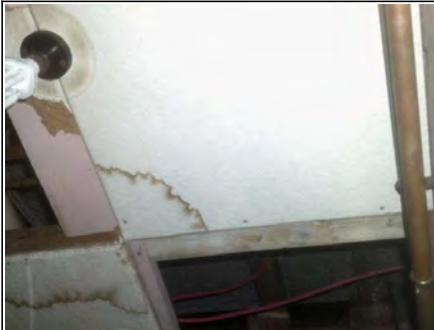
Room Number: 0-067		Room Reference: Cleaners Store		Review Date:
	Asbestos Detected	Sample Reference	Asbestos Type	Product Type	Surface Treatment
	No Asbestos Detected	017		Insulating Board (Unsealed)	
		Extent	Condition	Accessibility	Risk Score
		1-5m ²			0
	Comment:	No asbestos was detected in the sample of the insulating board panels to the ceiling ref: 28329/017.			
Recommendation:	No further action required.

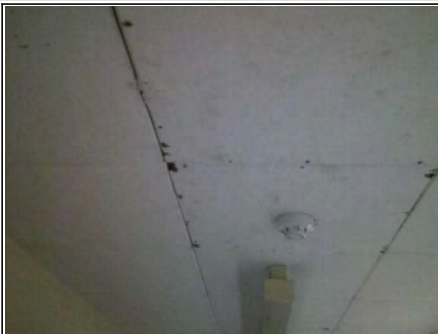
Room Number: 0-068		Room Reference: Corridor		Review Date:
	Asbestos Detected	Sample Reference	Asbestos Type	Product Type	Surface Treatment
	No Asbestos Detected	As017		Insulating Board (Unsealed)	
		Extent	Condition	Accessibility	Risk Score
	30-40m ²			0

Comment:	No asbestos was detected in the sample of the insulating board panels to the ceiling ref: 28329/017.			
Recommendation:	No further action required.				
NO SUSPECT MATERIALS SEEN	Room Number: 0-069		Room Reference: Office		Review Date:
	Asbestos Detected	Sample Reference	Asbestos Type	Product Type	Surface Treatment
	No Asbestos Detected				
		Extent	Condition	Accessibility	Risk Score
				0

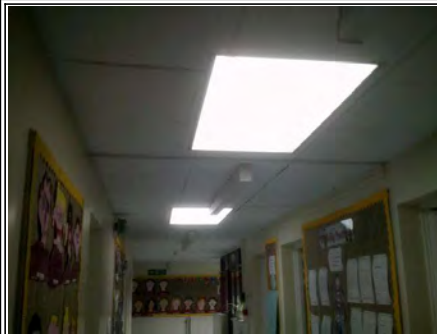
Room Number: 0-078		Room Reference: Corridor		Review Date:
	Asbestos Detected	Sample Reference	Asbestos Type	Product Type	Surface Treatment
	No Asbestos Detected	024		Insulating Board (Sealed)	
		Extent	Condition	Accessibility	Risk Score
		50-75m ²			0
	Comment:	No asbestos was detected in the sample of the insulating board panels to the ceiling ref: 28329/024.			
Recommendation:	No further action required.

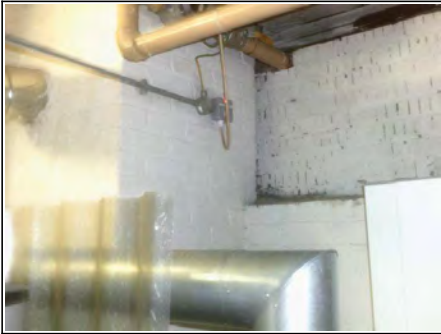
Room Number: 0-087		Room Reference: Boiler Room		Review Date:
	Asbestos Detected	Sample Reference	Asbestos Type	Product Type	Surface Treatment
	No Asbestos Detected	027		Debris	
		Extent	Condition	Accessibility	Risk Score
	40-50m ²			0

Comment:	No asbestos was detected in the sample of the dust and debris to the walls ref: 28329/027.			
Recommendation:	No further action required.

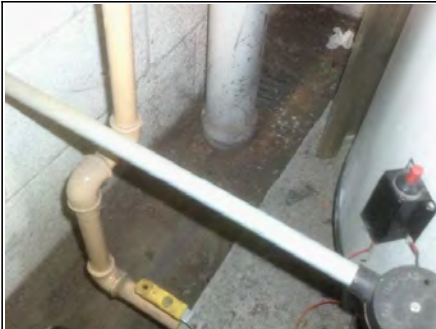
Room Number: 0-087		Room Reference: Boiler Room		Review Date:
	Asbestos Detected	Sample Reference	Asbestos Type	Product Type	Surface Treatment
	No Asbestos Detected	028		Debris	
		Extent	Condition	Accessibility	Risk Score
		20-25m ²			0
	Comment:	No asbestos was detected in the sample of the dust and debris to the floor ref: 28329/028.			
Recommendation:	No further action required.

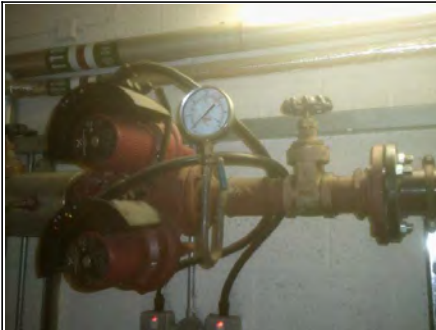
Room Number: 0-087		Room Reference: Boiler Room		Review Date:
	Asbestos Detected	Sample Reference	Asbestos Type	Product Type	Surface Treatment
	No Asbestos Detected	029		Gaskets	
		Extent	Condition	Accessibility	Risk Score
		Throughout			0
	Comment:	No asbestos was detected in the sample of the gaskets to the pipe work ref: 28329/029.			
Recommendation:	No further action required.

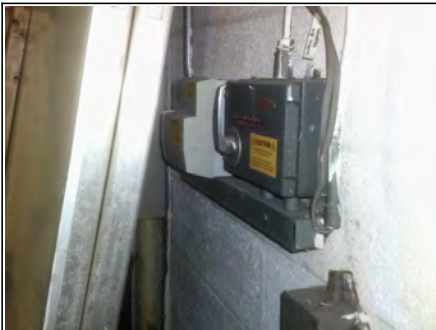
Room Number: 0-087		Room Reference: Boiler Room		Review Date:
	Asbestos Detected	Sample Reference	Asbestos Type	Product Type	Surface Treatment
	No Asbestos Detected	Negative Electrics		Negative Electrics	
		Extent	Condition	Accessibility	Risk Score
					0
	Comment:	The electrical system within the area was seen to be of a type non conducive to containing asbestos containing materials.			
Recommendation:	No further action required.

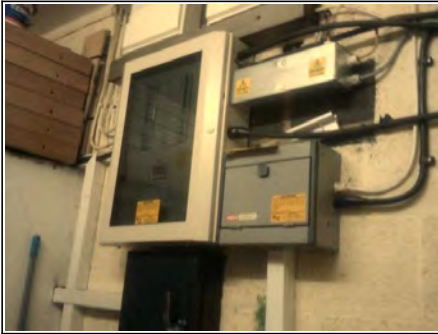
Room Number: 0-090		Room Reference: Store		Review Date:
	Asbestos Detected	Sample Reference	Asbestos Type	Product Type	Surface Treatment
	No Asbestos Detected	Negative Electrics		Negative Electrics	
		Extent	Condition	Accessibility	Risk Score
					0

Comment:	The electrical system within the area was seen to be of a type non conducive to containing asbestos containing materials and no further suspect asbestos containing materials were seen in the area at the time of the survey.			
Recommendation:	No further action required.

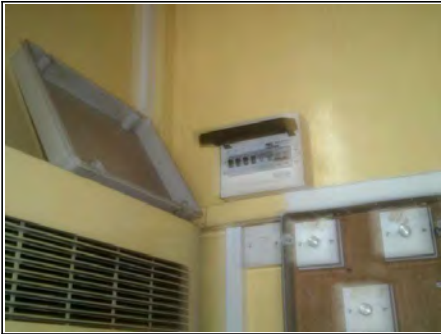
Room Number: 0-097		Room Reference: Assembly Hall		Review Date:
	Asbestos Detected	Sample Reference	Asbestos Type	Product Type	Surface Treatment
	No Asbestos Detected	Negative Electrics		Negative Electrics	
		Extent	Condition	Accessibility	Risk Score
					0

Comment:	The electrical system within the area was seen to be of a type non conducive to containing asbestos containing materials and no further suspect asbestos containing materials were seen in the area at the time of the survey.			
Recommendation:	No further action required.				
NO SUSPECT MATERIALS SEEN	Room Number: 0-098		Room Reference: Girls Toilet		Review Date:
	Asbestos Detected	Sample Reference	Asbestos Type	Product Type	Surface Treatment
	No Asbestos Detected				
		Extent	Condition	Accessibility	Risk Score
					0

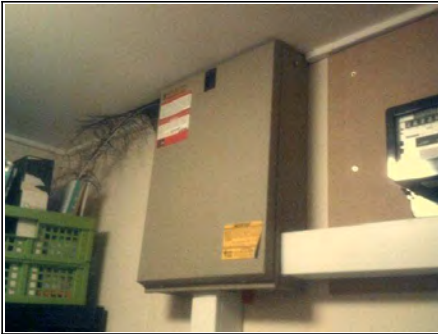
Room Number: 0-103		Room Reference: Store		Review Date:
	Asbestos Detected	Sample Reference	Asbestos Type	Product Type	Surface Treatment
	No Asbestos Detected	Negative Electrics		Negative Electrics	
		Extent	Condition	Accessibility	Risk Score
					0
	Comment:	The electrical system within the area was seen to be of a type non conducive to containing asbestos containing materials and no further suspect asbestos containing materials were seen in the area at the time of the survey.			
Recommendation:	No further action required.

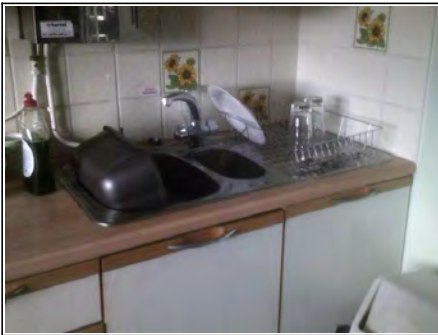
Room Number: 1-001		Room Reference: Staff Room		Review Date:
	Asbestos Detected	Sample Reference	Asbestos Type	Product Type	Surface Treatment
	No Asbestos Detected	015		Bitumen Sink Pad	
		Extent	Condition	Accessibility	Risk Score
		Number x 01			0
	Comment:	No asbestos was detected in the sample of the bitumen sink pad to the underside of the sink unit ref: 28329/015.			
Recommendation:	No further action required.

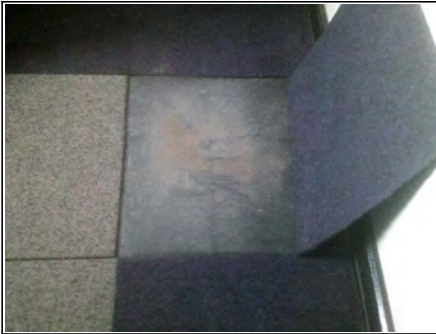
Room Number: 1-002		Room Reference: Landing		Review Date:
	Asbestos Detected	Sample Reference	Asbestos Type	Product Type	Surface Treatment
	No Asbestos Detected	016		Floor Tiles	
		Extent	Condition	Accessibility	Risk Score
		5-10m ²			0

Comment:	No asbestos was detected in the sample of the black floor tiles beneath the carpet ref: 28329/016.			
Recommendation:	No further action required.				
NO SUSPECT MATERIALS SEEN	Room Number: 1-003		Room Reference: Tank Room		Review Date:
	Asbestos Detected	Sample Reference	Asbestos Type	Product Type	Surface Treatment
	No Asbestos Detected				
		Extent	Condition	Accessibility	Risk Score
					0

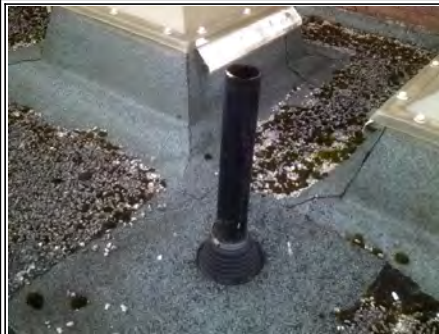
Room Number: External		Room Reference: To Main Building		Review Date: 18-02-2020	
Asbestos Detected	Sample Reference	Asbestos Type	Product Type	Surface Treatment	
Asbestos Confirmed	035	Chrysotile	Cement Flue Pipe	Cement	
	Extent	Condition	Accessibility	Risk Score	
	Number x 02	0 - Good	Difficult	3	
Comment:	The cement flue pipes to the roof of the main building were seen to be in good condition at the time of the survey.				
Recommendation:	The condition of the cement flue pipe should be monitored.

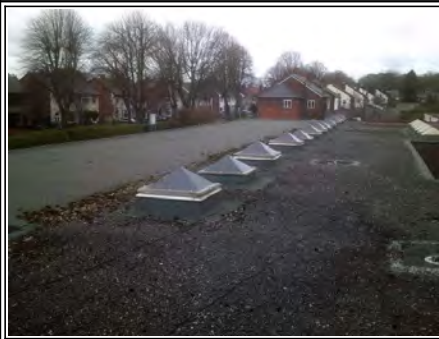
Room Number: External		Room Reference: To Main Building		Review Date:	
Asbestos Detected	Sample Reference	Asbestos Type	Product Type	Surface Treatment	
No Asbestos Detected	036		Roofing Felt		
	Extent	Condition	Accessibility	Risk Score	
	Whole Roof			0	
Comment:	No asbestos was detected in the sample of the roofing felt to the flat roof ref: 28329/036.				
Recommendation:	No further action required..

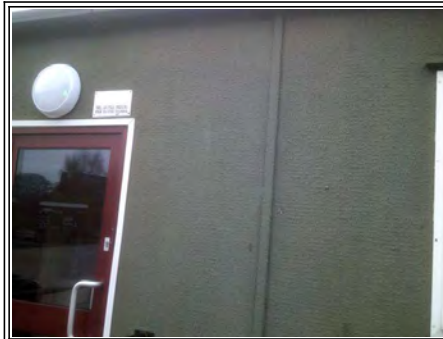
Room Number: External 1		Room Reference: To Mobile Classroom		Review Date:
Asbestos Detected	Sample Reference	Asbestos Type	Product Type	Surface Treatment
No Asbestos Detected	030		Textured Coating	
	Extent	Condition	Accessibility	Risk Score
	100-150m ²			0
Comment:	No asbestos was detected in the sample of the textured render to the walls of the mobile ref: 28329/030.			
Recommendation:	No further action required.

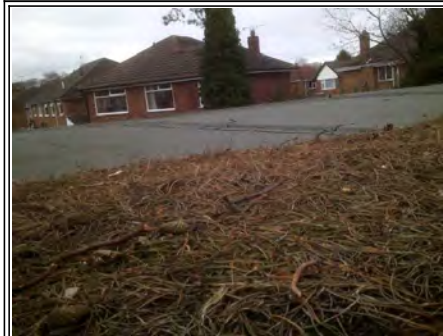
Room Number: External 1		Room Reference: To Mobile Classroom		Review Date:
Asbestos Detected	Sample Reference	Asbestos Type	Product Type	Surface Treatment
No Asbestos Detected	031		Roofing Felt	
	Extent	Condition	Accessibility	Risk Score
	100-150m ²			0
Comment:	No asbestos was detected in the sample of the roofing felt to the flat roof ref: 28329/031.			
Recommendation:	No further action required.

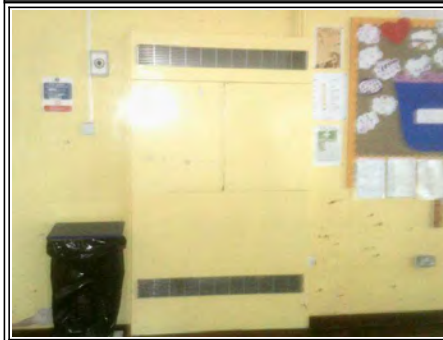
Room Number: Internal		Room Reference: To School		Review Date: 18-02-2020
Asbestos Detected	Sample Reference	Asbestos Type	Product Type	Surface Treatment
No Access	Suspect Heaters		No Access	
	Extent	Condition	Accessibility	Risk Score
				3
Comment:	No Access was possible into the live suspect heaters throughout the school at the time of the survey.			
Recommendation:	The presence of asbestos containing materials should be presumed until further investigation is carried out. Further investigation is recommended prior to demolition or major refurbishment works.

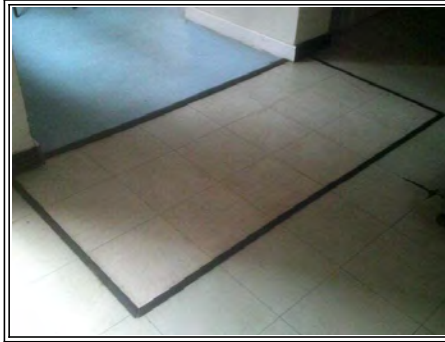
Room Number: Internal		Room Reference: To School			Review Date: 18-02-2020
Asbestos Detected	Sample Reference	Asbestos Type	Product Type	Surface Treatment	
No Access	Suspect Floor Ducts		No Access		
	Extent	Condition	Accessibility	Risk Score	
				3	
Comment:	No Access was possible into the Subterranean Floor Ducts throughout the school at the time of the survey.				
Recommendation:	The presence of asbestos containing materials should be presumed until further investigation is carried out. Further investigation is recommended prior to demolition or major refurbishment works.
